# Service Bulletin

Bulletin No.: 24-NA-166

**Subject: DTC C1171 C1172 C1173 C1174 Tire Pressure Monitor Sensor Unable to Relearn Ethernet Cable Overlay for TCP OnStar Module**

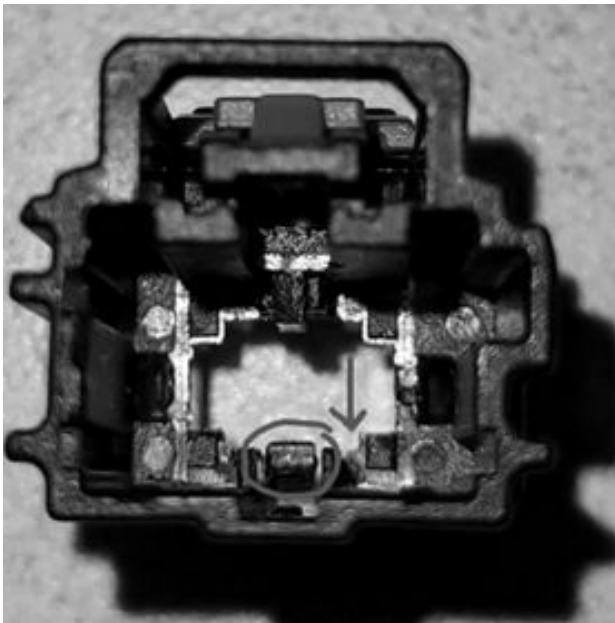
6720422

The X7 housing tab is very difficult to see with the cable installed.
