## STAR ONLINE PUBLICATION

**Case Number:** S2408000063 Rev. B

**Release Date:** October 2024

**Symptom/Vehicle Issue:** Service Hybrid Electric Vehicle System Warning Message And Light Are Displayed. B273C-00 - Digital Crash Input Set In HCP

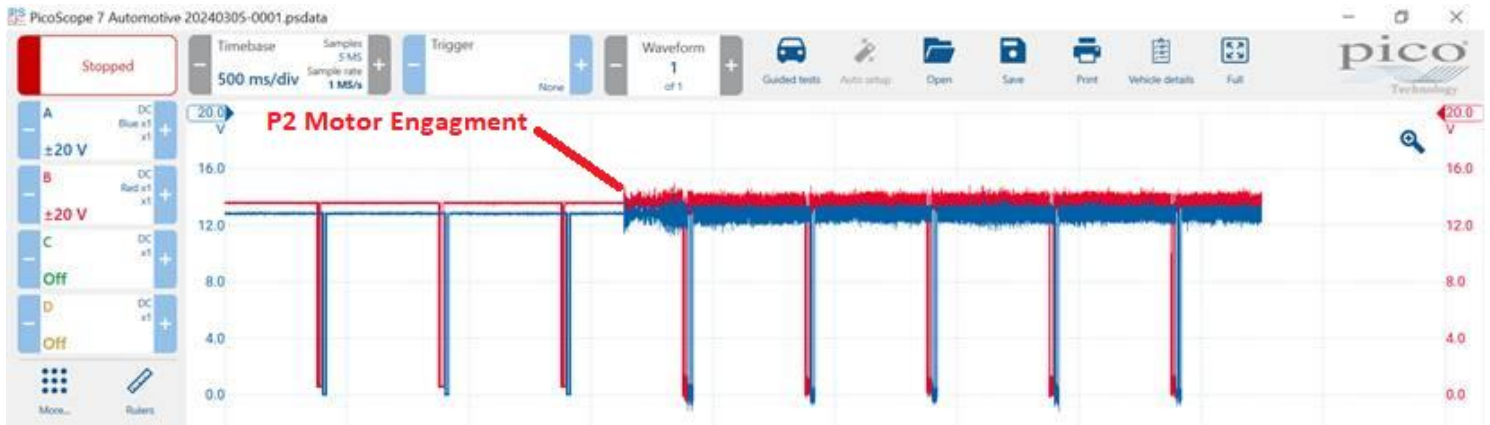
This issue may be caused by Electromagnetic Interference (EMI) from the High Voltage (HV) P2 Motor and associated HV harnesses which can transfer inductive voltage/electric noise onto the R41 - Airbag Deployment Signal and R414 - Airbag Deployment Signal 2 circuits. This inductive voltage/electric noise corrupts the health status signal and causes the B273C-00 – Digital Crash Input DTC to set.

**Diagnosis:** Connect an oscilloscope such as the Mopar PicoScope to the R41 and R414 circuits. When the P2 motor engages and begins operating, look for a distinctive change in the voltage pattern which would confirm the presence of induction voltage/ electrical noise, See Fig. 1. Some EMI on these circuits is expected during normal operation; however, some vehicles will exhibit more than others. If the electric noise is beyond the acceptable threshold, B273C-00 – Digital Crash Input will set in the HCP almost immediately after the noise is detected on the oscilloscope.

**Fig. 1 :Electrical Noise on R41 and R414 Circuit After P2 Motor Engagement**

**Repair:** As stated, some EMI is normal and will be observed on all vehicles and will not induce any faults. However, if B273C-00 only becomes Active when electrical noise is detected on R41 and R414 with an Oscilloscope. Excessive EMI on these circuits should be considered the root cause.

**A HCP, AHCP and PCM software update and wiring harness repair is expected to be released in the form of a TSB/RSU in Q4 2024. This software will increase the HCPs ability to detect a valid Digital Crash Input health signal when excessive EMI is present. The wiring harness repair will help eliminate excessive EMI.**

1. BPCM to Battery Coolant Heater HV Harness: 68593178AC
2. P2 to PIM HV Harness: 68593176AB
3. P1 to PIM HV Harness: 68593175AB
4. BPCM to IDCM HV Harnesses: 68378608AF
5. ORC (Reference STAR Parts for Part # and review TechTip)

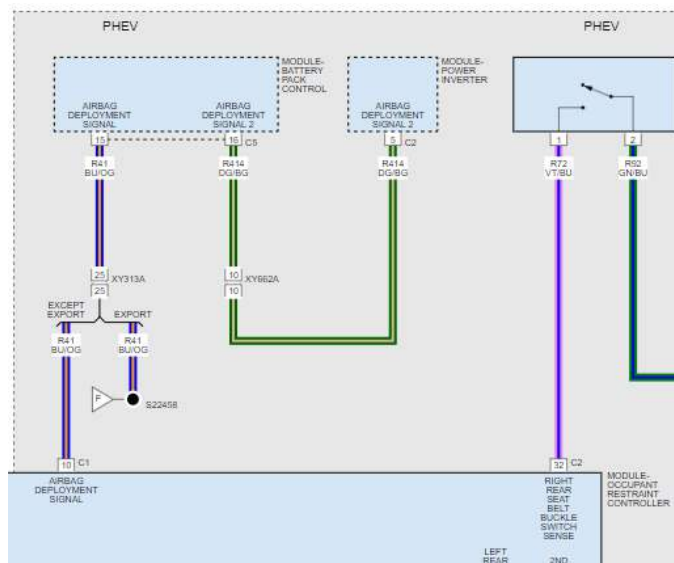
### Fig 2: Airbag Deployment Signal Circuits (R41 and R414)
