# TECHNICAL SERVICE BULLETIN

| RS19-005D | ITB19-024D | September 19, 2024 |

## DTC B00A0-00 STORED

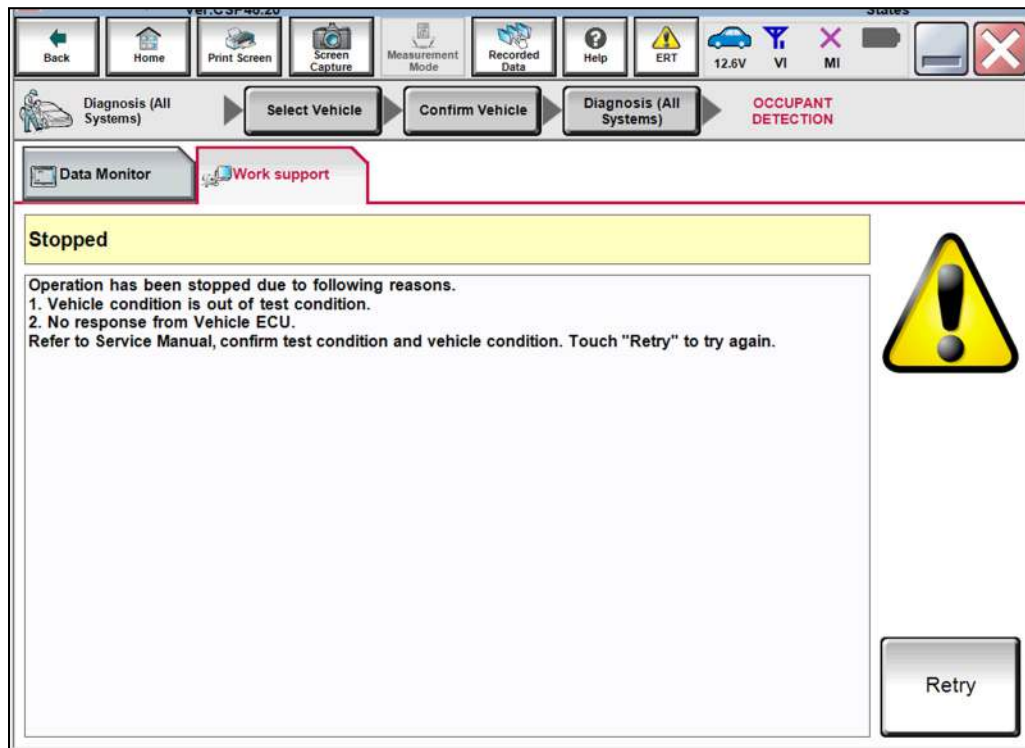
Figure 1

DTC B00A0-00 (OCCUPANT DETECTION SENSOR UNIT) is stored,

OCS zero point reset cannot be performed,

The following screen displays:

1. Check the Occupant Classification System (OCS) control unit using the ODS Analysis tool software.

2. Perform "75-Zero RESET".

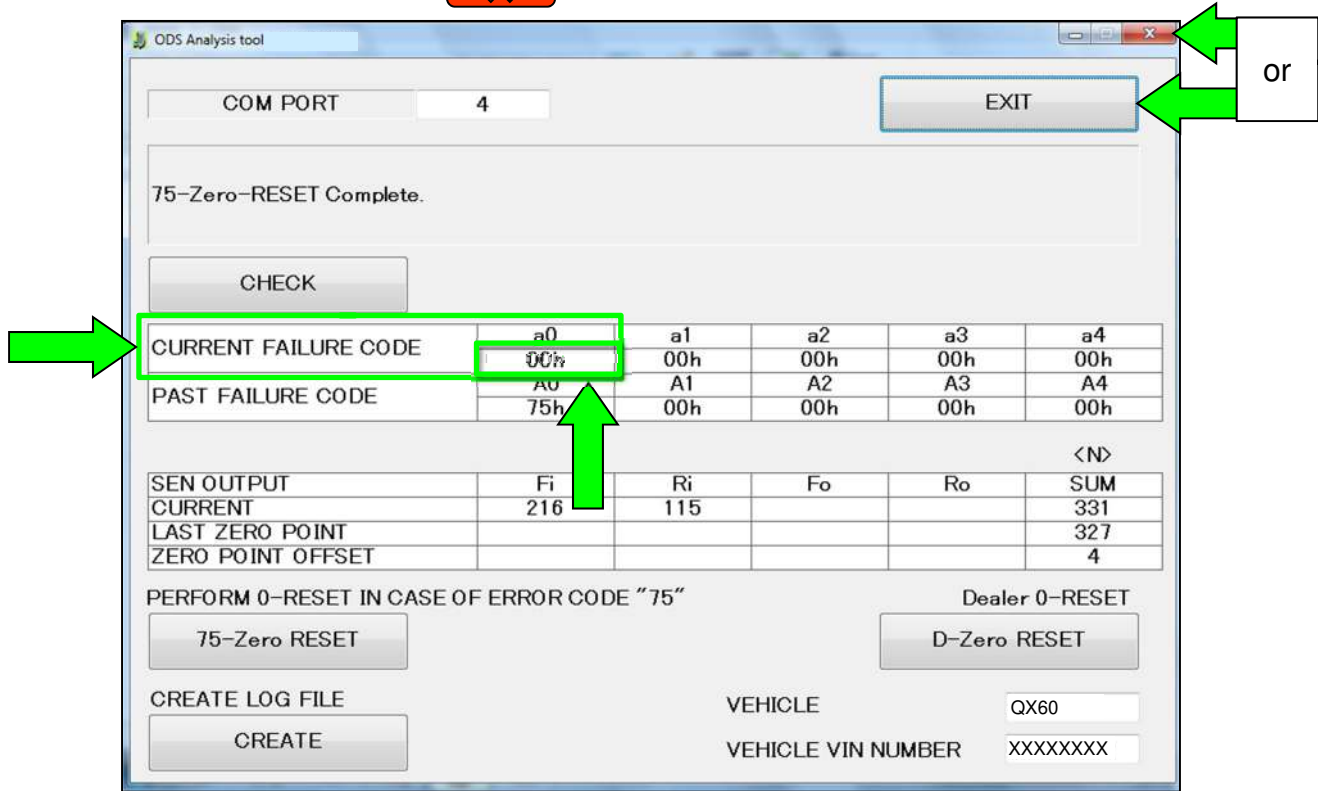
16. When the screen in Figure 9 displays, the 75-Zero reset process is complete.
  - Verify code “75h” is not displayed under **CURRENT FAILURE CODE**.
17. Select either **EXIT** or the
