# TECHNICAL SERVICE BULLETIN

RS19-004D

NTB19-071D

## DTC B00A0-00 STORED

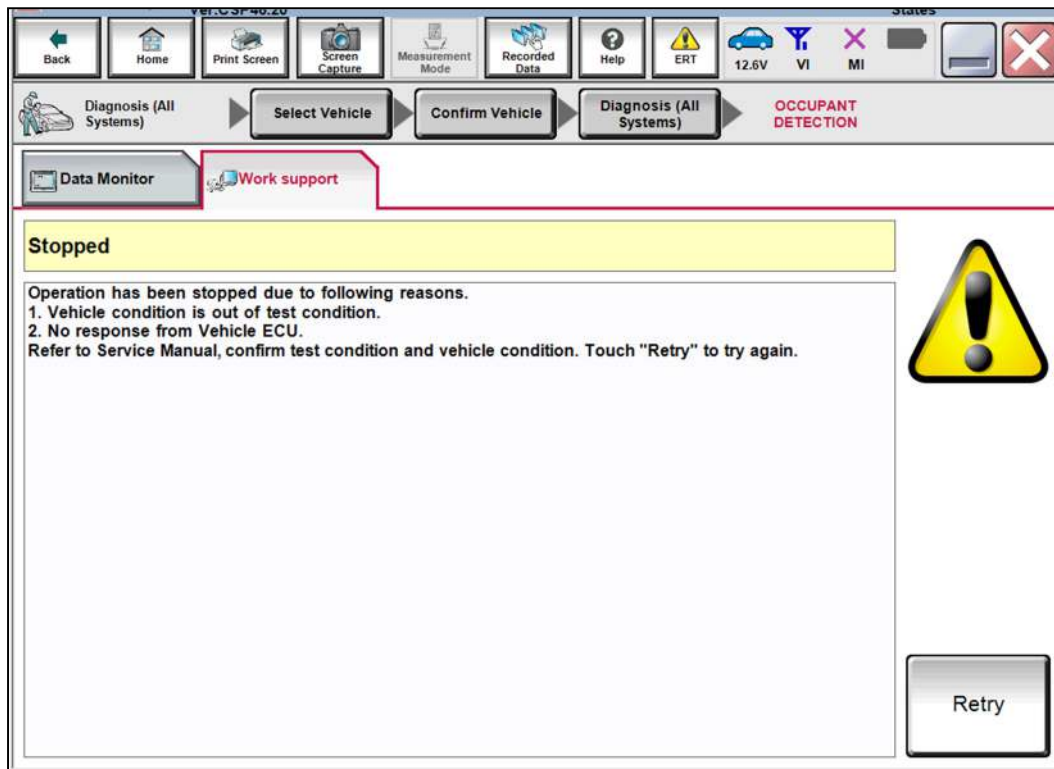
Figure 1

### IF YOU CONFIRM

DTC B00A0-00 (OCCUPANT DETECTION SENSOR UNIT) is stored,

### AND

OCS zero point reset cannot be performed,

**AND**

The following screen displays:

1. Check the Occupant Classification System (OCS) control unit using the ODS Analysis tool software.
  - Refer to **SERVICE PROCEDURE** on page 4.

**HINT:** "OCS" also may be referred to as "ODS".
2. Perform "75-Zero RESET".
