# Service Bulletin

Bulletin No.: 24-NA-027

**Subject: DTC U3000 Setting in Automated Map Module (HDLM) – Super Cruise Unavailable**

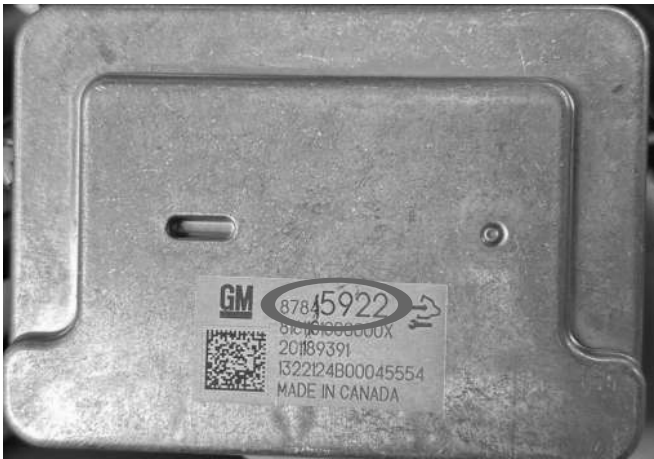
If one of these Map module part numbers listed in Parts Information is not installed in the vehicle, and the map module is setting the U3000 DTC with Super Cruise being unavailable, do not replace the module until additional diagnostics through SI are completed.

| Correction | Technicians are asked to verify the condition by driving on 2 different verified Super Cruise roads. Replace the HDLM module if, and only if, the part number of the HDLM in the vehicle is listed in Parts Information.<br><b>Important:</b> Please refer to the Electronic Parts Catalog (EPC) to order the latest release part number for this module. |
