# Service Bulletin

Bulletin No.: 24-NA-088

**Subject:** Diagnostic Tip for Malfunction Indicator Lamp (MIL) Illuminated, Transmission Not Shifting/Default Mode - DTC P0747 Set

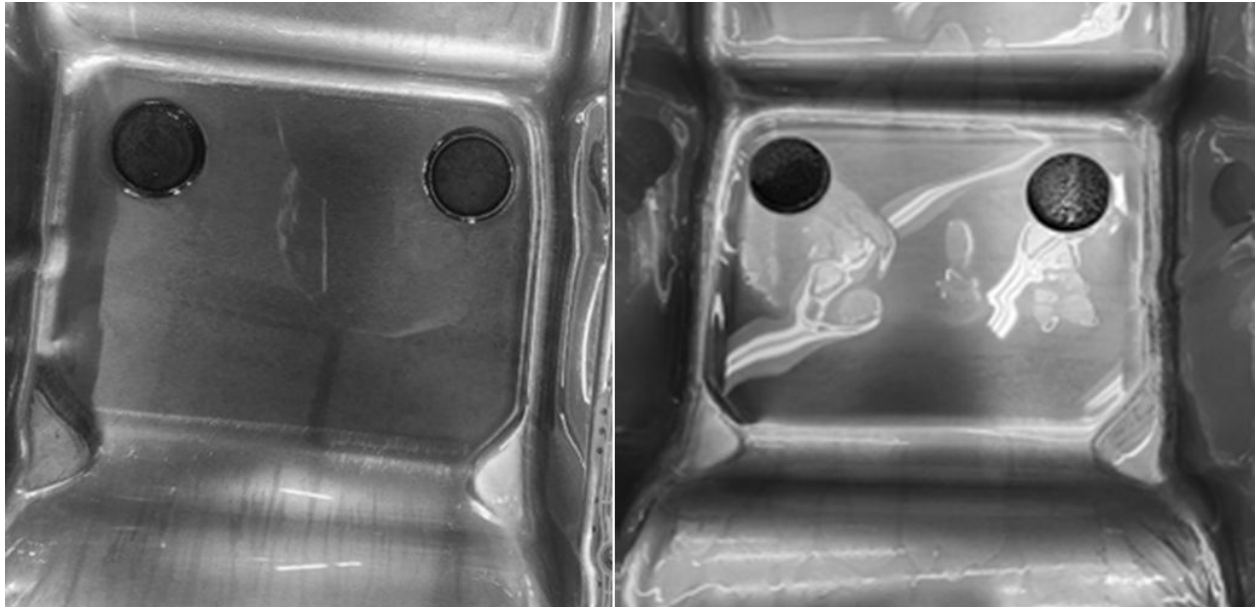
6639318

The fluid in the graphic above shows good color with no evidence of clutch material. This unit should be serviced with a valve body.

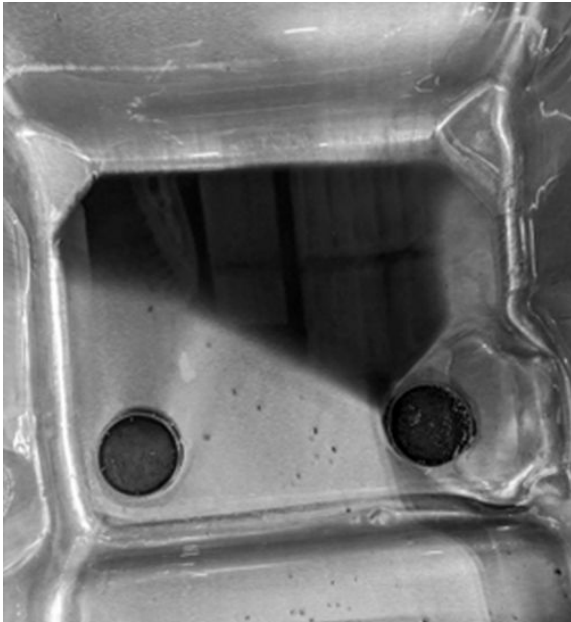
6639319

The fluid in the graphic above shows dark color with minimal evidence of clutch material. This unit did not exhibit a burnt odor. This unit should be serviced with a valve body.

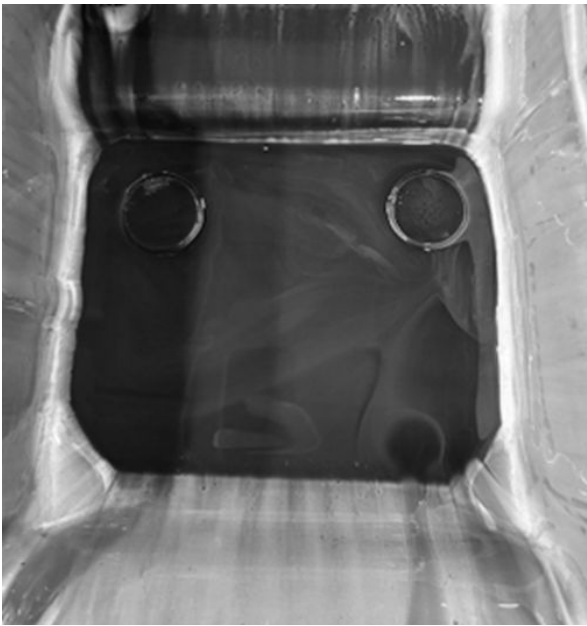
6639320

The fluid in the graphic above shows extreme distress and clutch material is starting to appear in the pan. This unit should be removed from the vehicle and disassembled for inspection to determine what clutches have been damaged. Any suspect clutch should be repaired following published Service Information (SI), or the unit replaced following Policy and Procedure Cost vs Replace guidelines. The control valve body should be replaced as well.
