# Technical Service Bulletin

## 01 Turbocharger: Adjustment unit for turbocharger; P256300, P056E00, P00AF00

01 24 39 2075010/1 September 26, 2024.

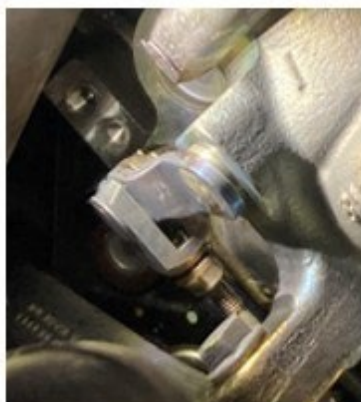
*Figure 1. Turbocharger adjustment unit close-up.*

- Spray the turbocharger adjustment unit with rust remover,
- Try to loosen the adjustment unit using the final control diagnosis.
- If this is not possible, continue with the steps listed under “with turbocharger removed.”

- Removed the turbocharger as described in the workshop manual.
- With the turbocharger removed, attempt to restore the function of the turbocharger adjustment unit with workshop materials (rust remover, pliers, etc.).
- Then lubricate the fork joint with high temperature paste G052112A3.
- Install the turbocharger as described in the workshop manual.
- Perform final control diagnosis.

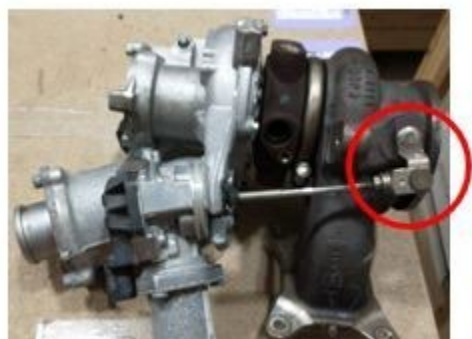
*Figure 2. Turbocharger adjustment unit.*

- The turbocharger must be replaced if it is not possible to loosen the turbocharger linkage. Lubricate the new fork joint with high temperature paste G052112A3.
