# Technical Service Bulletin

## 69 Airbag warning lamp lights up, event memory entry "B100B1B or B100A1B"

69 24 15 2075121/1 September 23, 2024.

| Model(s) | Year | VIN Range | Vehicle-Specific Equipment |
|---|---|---|---|
| A3, S3, and RS 3 | 2022 -2025 | All | Not Applicable |

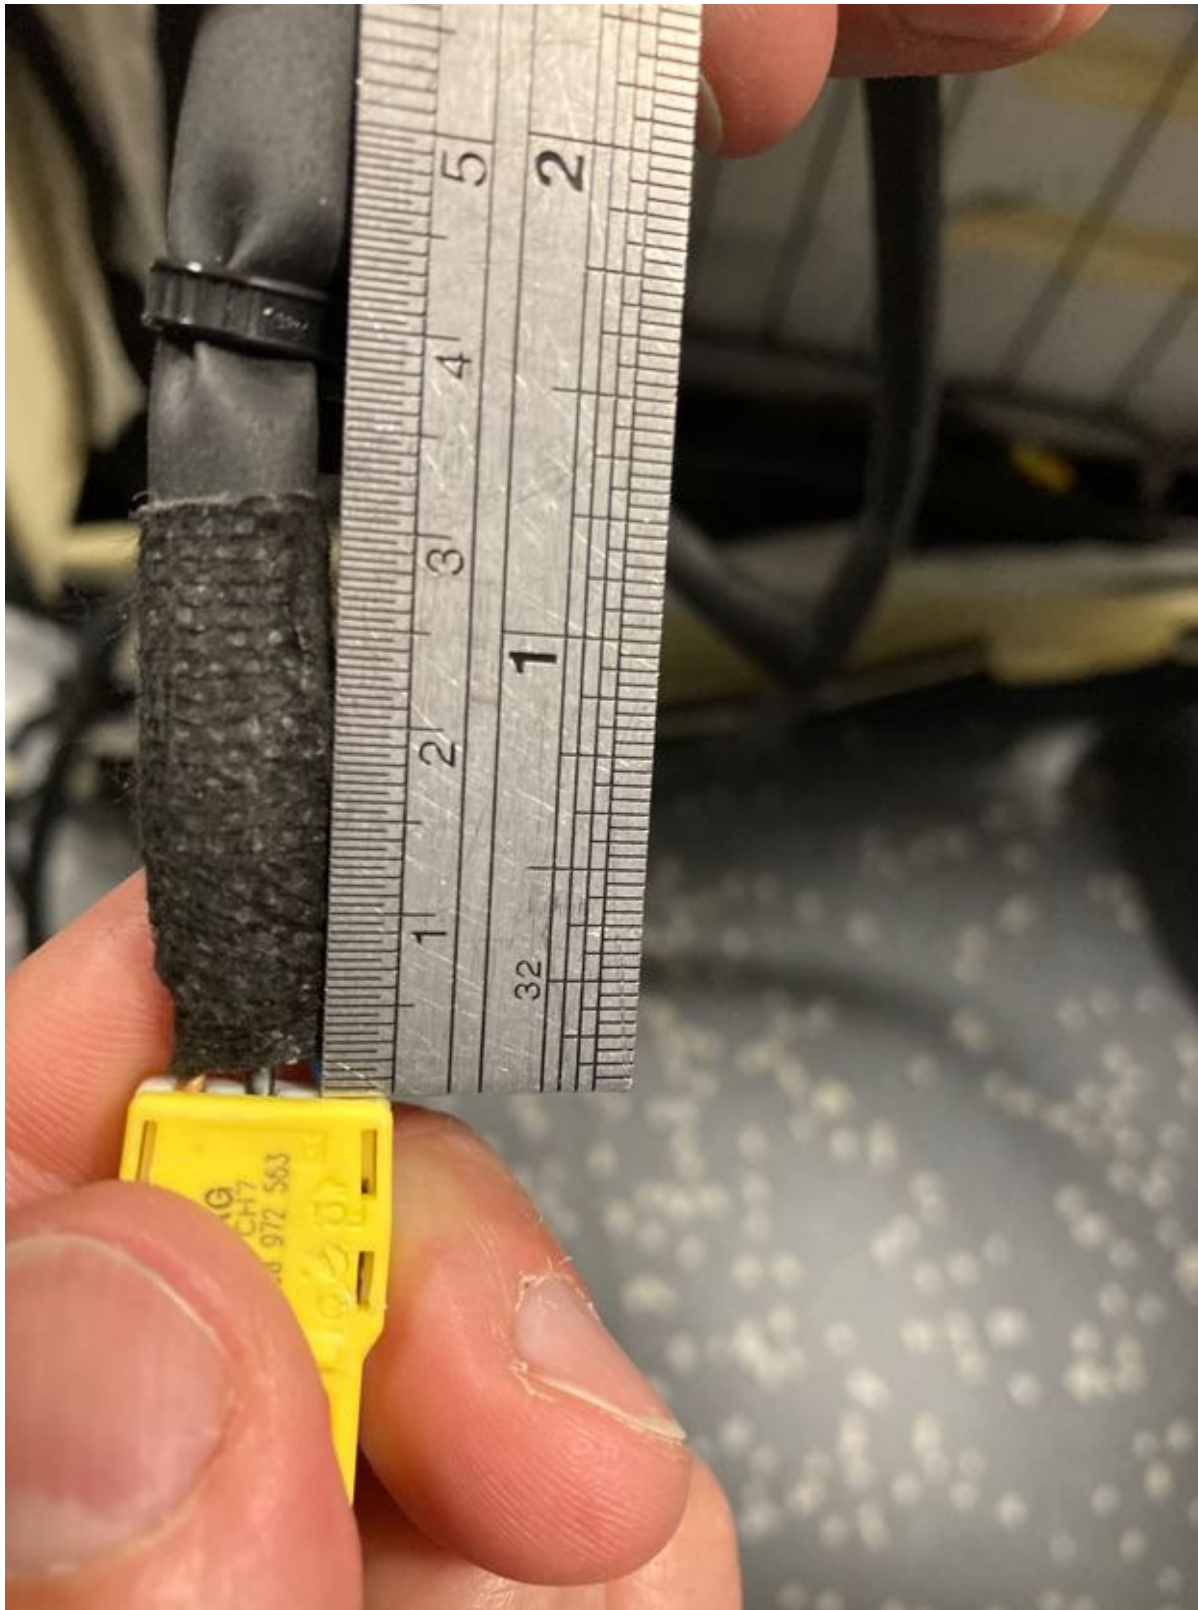
**Figure 1.** Attach the additional clip as shown.

1. Unplug the cable and attach the clip as shown (Figure 1).

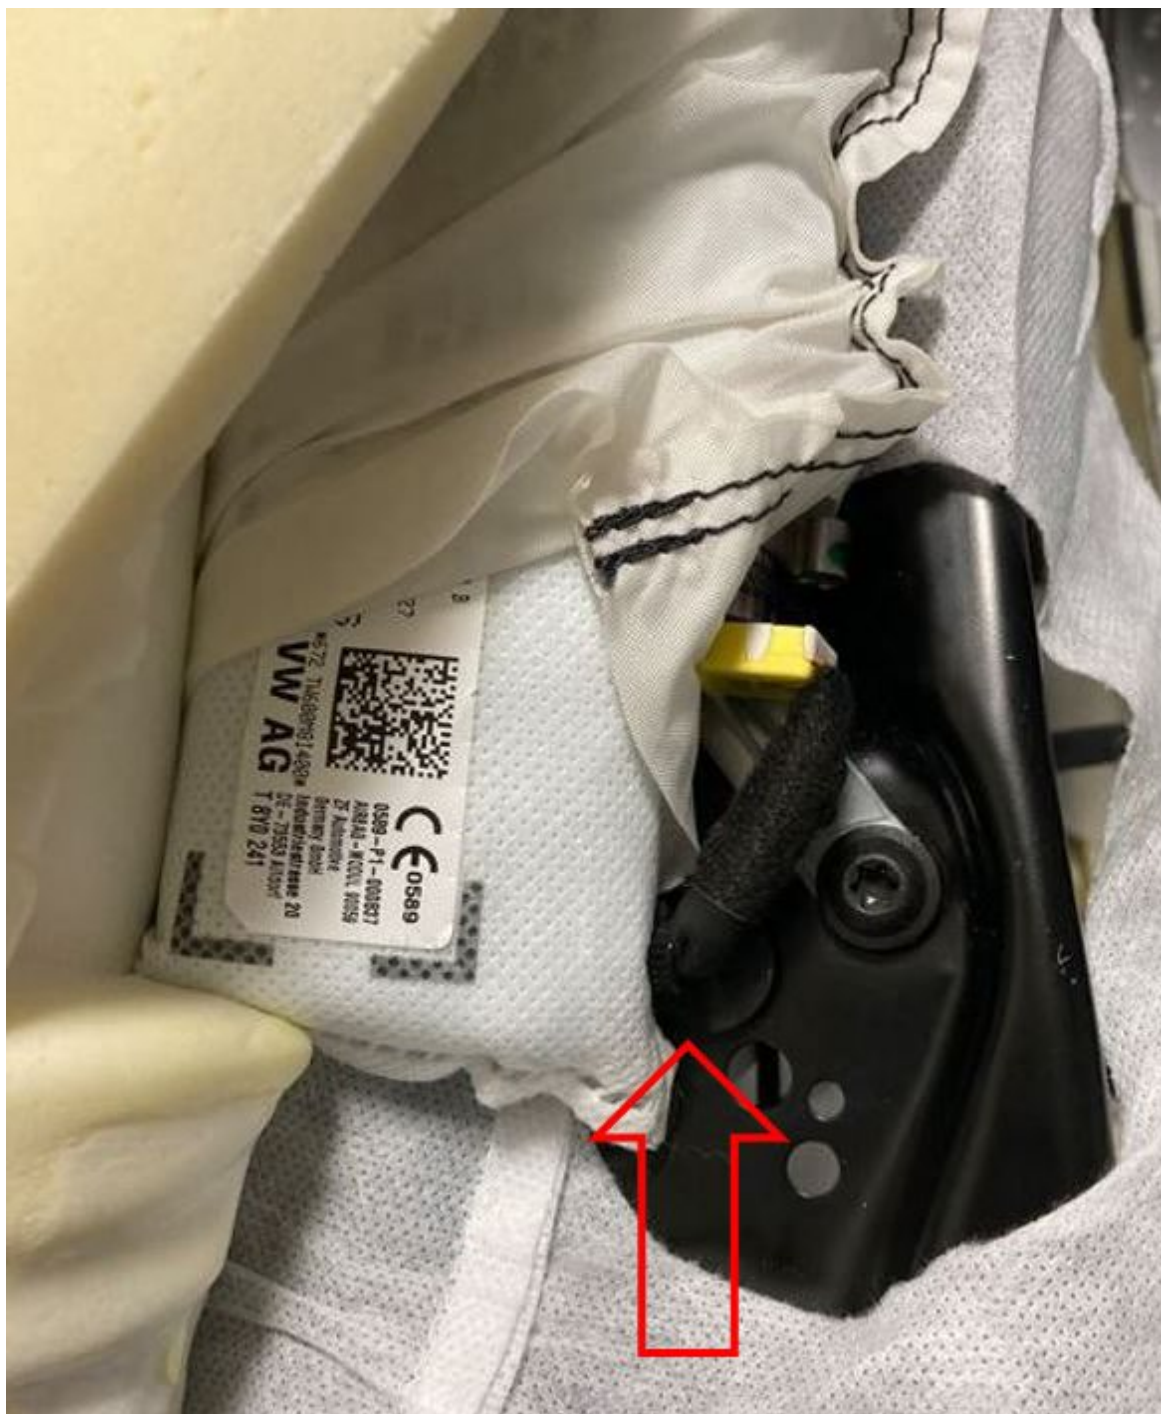
**Figure 2.** Attach the clip to the seat frame as shown.

2. The clip can then be attached to the seat frame and the connector can be plugged back in and locked (Figure 2).

**IMPORTANT: Lock connector again afterwards!**
