# Technical Service Bulletin

## 93: High-Voltage fault, gearbox fault or MIL on in the instrument cluster DTC(s) P0A4000, P0A2E00 or P0A2B00

93 24 14 2066596/3 September 18, 2024. Supersedes Technical Service Bulletin Group 93 number 24-00 dated July 31, 2024 for reasons listed below.

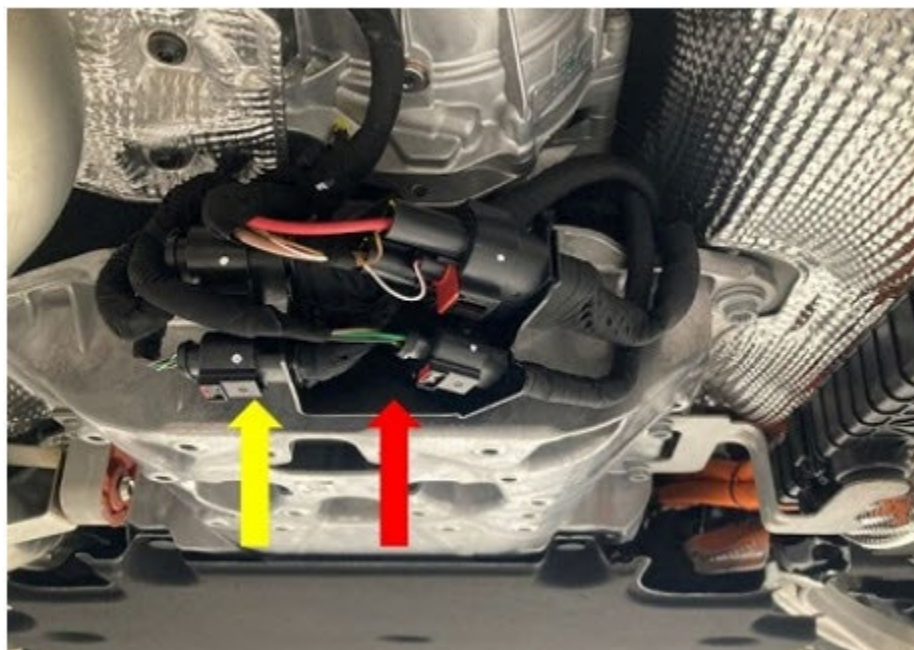
**Figure 1.** Connector locations.

Contact abrasion in connector T6bm / T6bmx.

1. Replace the connector housing bracket installed in the vehicle with the new bracket 8W0.971.502.AL (Figure 1 red arrow).
2. Replace the connector at the coupling point T6bm/T6bmx with 3B0.973.813 and 4H0.973.713.G (Figure 1 yellow arrow).
3. Replace all the pins in the new connector and mating connector with gold-plated pins using the wiring harness set VAS 1978B/C.
4. For modified connector 3B0.973.813, use single wires 000.979.041.EA and for connector 4H0.973.713.G use single wires 000.979.025.EA.
