| <b>HYUNDAI</b><br><b>Technical Service Bulletin</b> | GROUP<br><b>ENGINE</b> | NUMBER<br><b>24-EM-008H</b> |
| | DATE<br><b>OCTOBER 2024</b> | MODEL(S)<br><b>VENUE (QX)</b> |
| <b>SUBJECT:</b> ECU UPDATE – DTC P250F OIL LEVEL SENSOR WARNING LIGHT LOGIC | | |

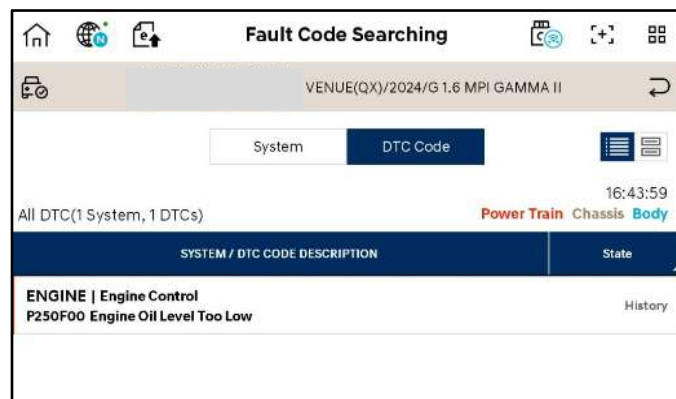
5. If **DTC P250F** is found, continue to check the engine oil level in **Step 6** prior to performing the ECU update.

- If any other DTC is found, this TSB does **NOT** apply. Follow the DTC Guide to appropriately diagnose and repair the vehicle.

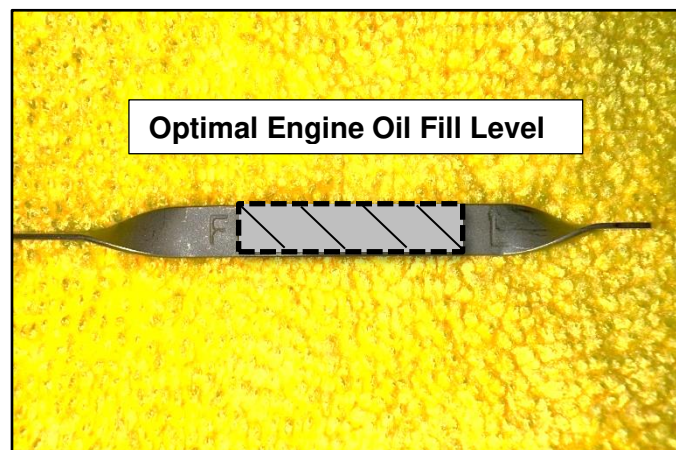
6. Inspect the engine oil level using the vehicle's engine oil dipstick.

- If the oil level is between the low ('L') and full ('F') line (optimal engine oil fill level), then proceed to the **ECU Update Procedure** to perform the ECU logic update.
- If the oil level is below the low ('L') line, then **DO NOT** proceed with the ECU logic update. Follow normal diagnostic procedures to diagnose the low oil level condition.
