# Service Bulletin

Bulletin No.: 24-NA-200

**Subject: DTC HPCM2 Software Update for Using NACS DC Fast Charge Adapter, Possible DTC(s) P3013 or P302D**

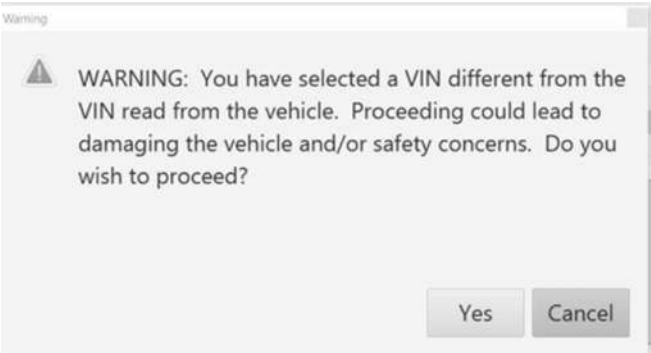
5877000

**Important:** If the vehicle VIN DOES NOT match, the message below will be shown.

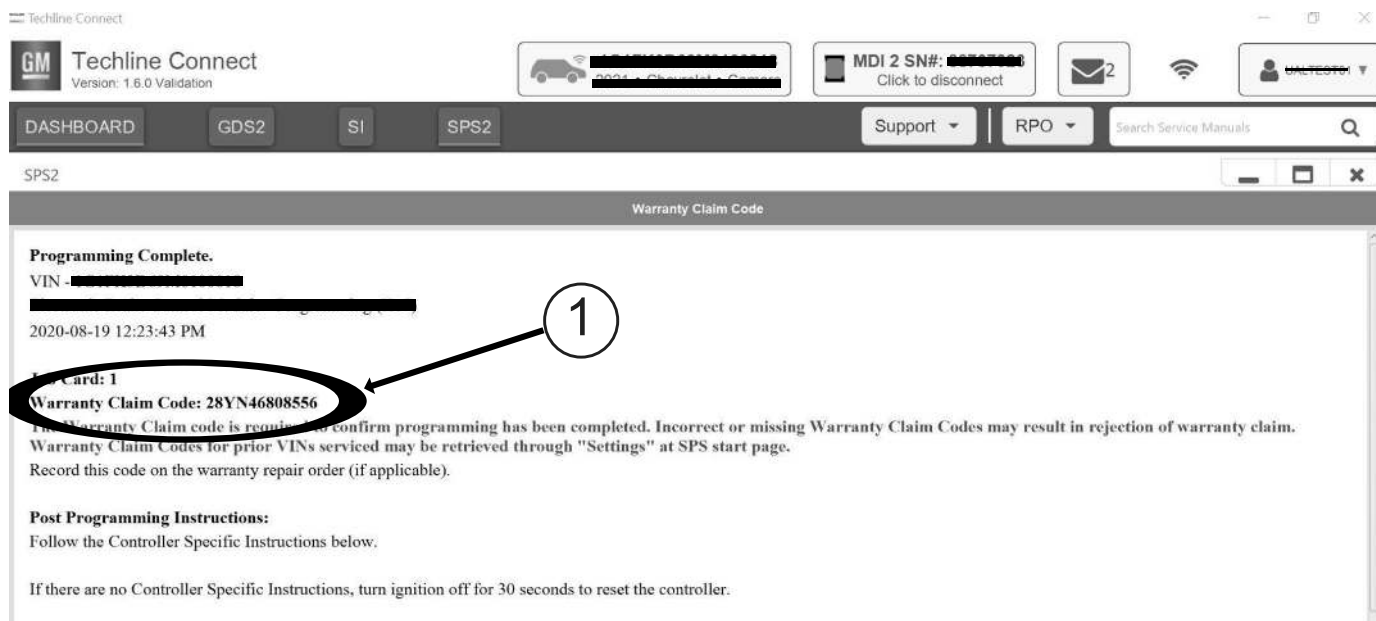
5644478

**Note:** The screenshot above is an example of module programming and may not be indicative of the specific module that is being programmed. Module selection and VIN information have been blacked out.

**Important:** To avoid warranty transaction rejections, you **MUST** record the warranty claim code provided on the Warranty Claim Code (WCC) screen shown above on the job card. Refer to callout 1 above for the location of the WCC on the screen.

2. Record the SPS Warranty Claim Code on the job card for warranty transaction submission.
