# Service Bulletin

Bulletin No.: 24-NA-106

**Subject:** Malfunction Indicator Lamp (MIL) Illuminated – DTCs P00C6, P312B, P217D, P2149, P312C, P01BF, P2CA0, P216D, P2155, P228C, and/or U101C Set

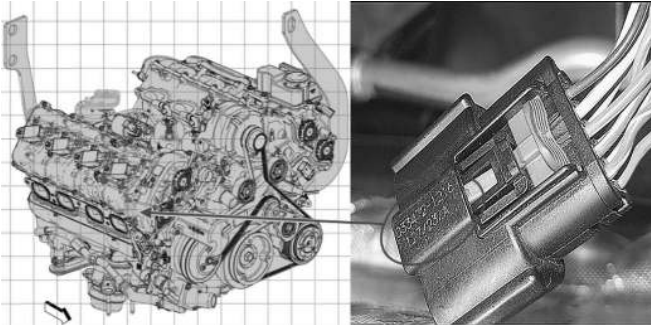
6657948

| Cause | <p>This condition may be caused by an incorrect 12-way in-line connector which leads to the bank 2 fuel rail assembly. This connector may have an open cavity allowing water intrusion into the fuel injector wiring harness.</p> |

Inspect the 12-way in-line electrical connector at the Fuel Injector Wiring Harness - Bank 2:

- If the connector part number 33472-1216 is on the connector as shown in the graphic above, that is the correct connector. Refer to the applicable DTC in service information for further diagnosis and repair.
- If the connector part number **IS NOT** 33472-1216, then it will be necessary to replace the engine harness, engine harness bracket (if applicable), fuel rail pressure sensor, and the fuel injection wiring harness.

Refer to *Fuel Injector Wiring Harness Replacement* and *Fuel Rail Pressure Sensor Replacement* in SI.
