# Service Bulletin

Bulletin No.: 24-NA-204

**Subject:** Ignition Button LED Inoperative and/or Lights in the Dash Flicker or Not Illuminate, Possible B1837 - LED Backlight Dimming Control Set and Blown IP Fuse F9DA

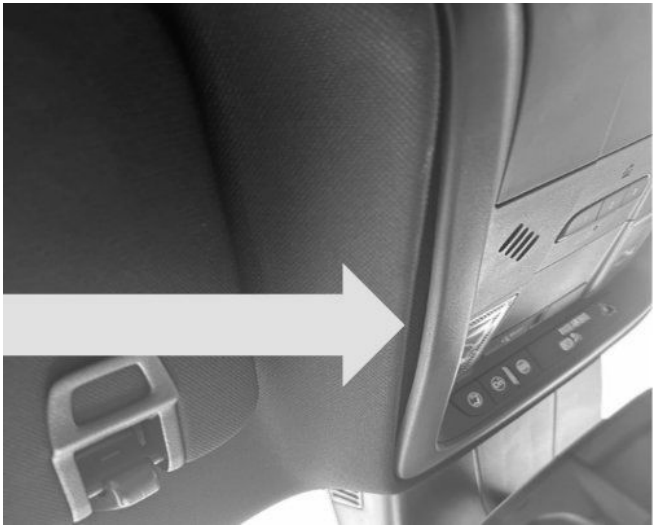
| Cause | <div></div> <p>The cause of the condition may be improper routing of the overhead console harness being clipped into the roof sometimes resulting in a bulge in the overhead console like illustrated above.</p> <p>6737910</p> |

| Correction | Refer to the procedure outlined below. |
