# Service Bulletin

Bulletin No.: PIE0802

**Subject:** Engineering Information - Check Engine Lamp Illuminated on the Driver Information Center (DIC), DTC P0202 Set

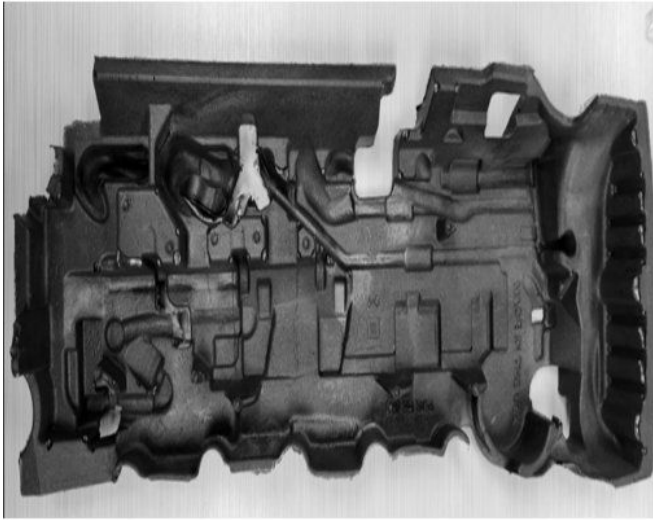
6737562

1. Remove and inspect Cam Shaft Housing Cover Insulator and take a clear picture of the underside of the insulator, as shown in the picture above, and document where any contact between the insulator and the wire harness may have occurred.

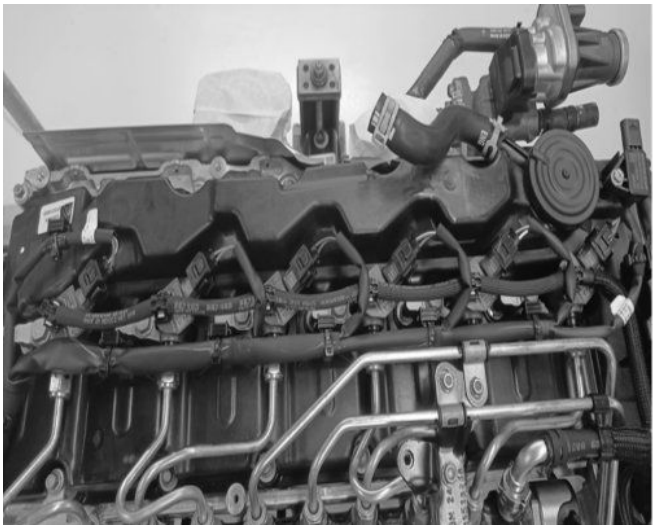
6737567

2. Prior to removing the wire harness, take a clear picture of the wire harness on the engine, as shown in the picture above, and document any possible between the insulator and the wire harness.

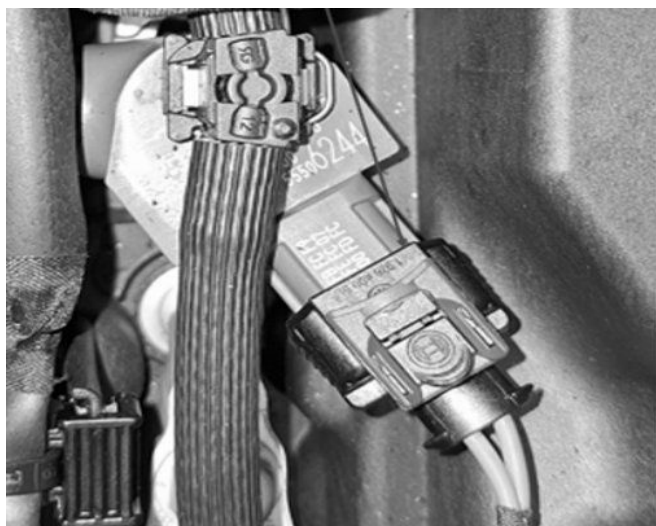
6737575

3. Prior to removing the wire harness, verify that the wiring harness connector is properly engaged, and CPA is in closed position, as shown in the picture above.

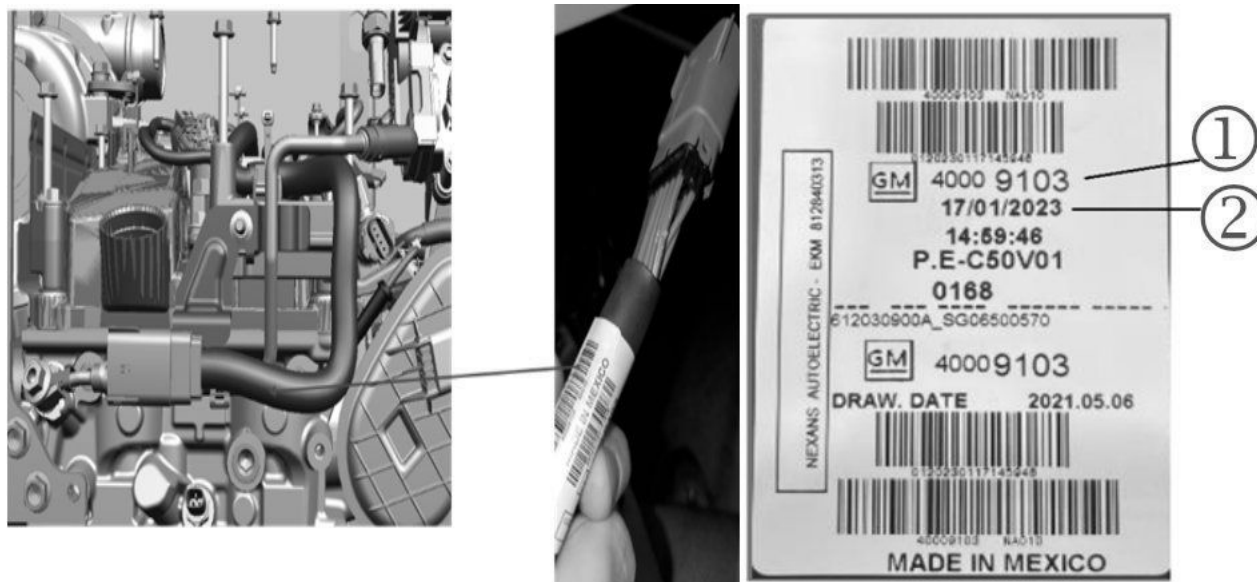
6737593

4. Document the harness P/N# (1) and the wire harness Build date (2), as shown in the picture above.

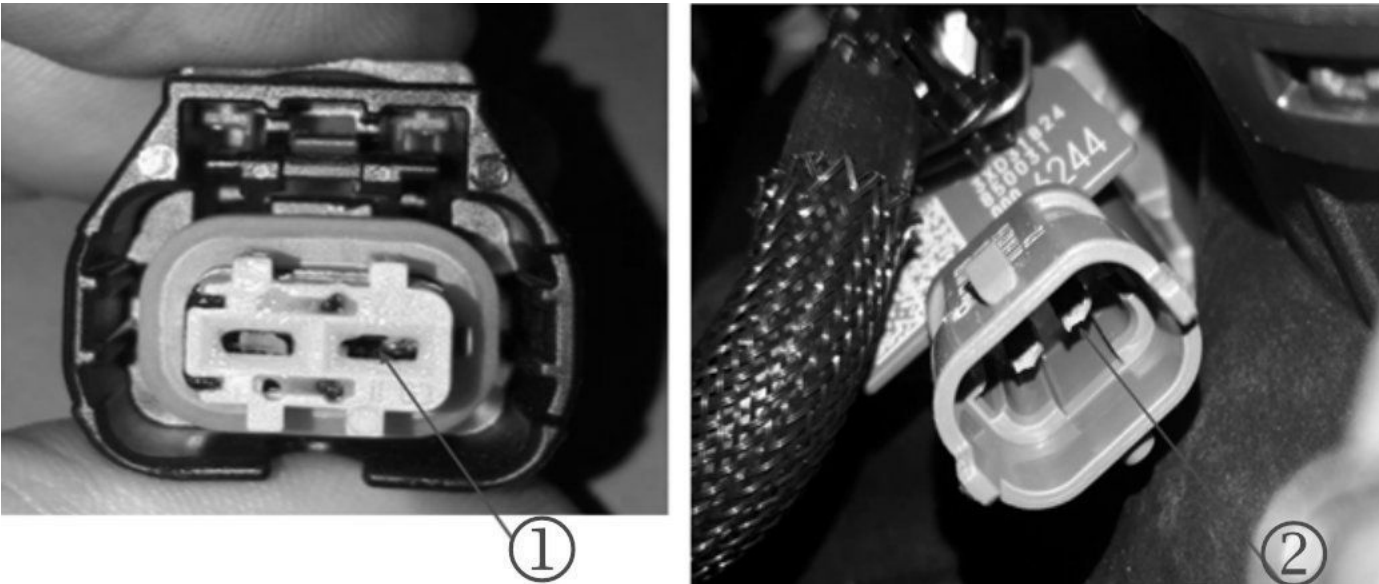
6737643

5. Take a clear picture of harness connector (1) and the injector device (2) connector, as shown in the picture above, and look for presence of grease and any sign of burnt.
6. Perform a terminal drag test at harness connector, to verify no loose pins.
