## Anti-theft alarm system triggers without obvious cause

| Topic number | LI80.50-P-077350 |
| Function group | 80.50 - Anti-theft alarm system (ATA), Interior motion sensor/Tow sensor |
| Validity | MODEL 118,177,243,247,167 |

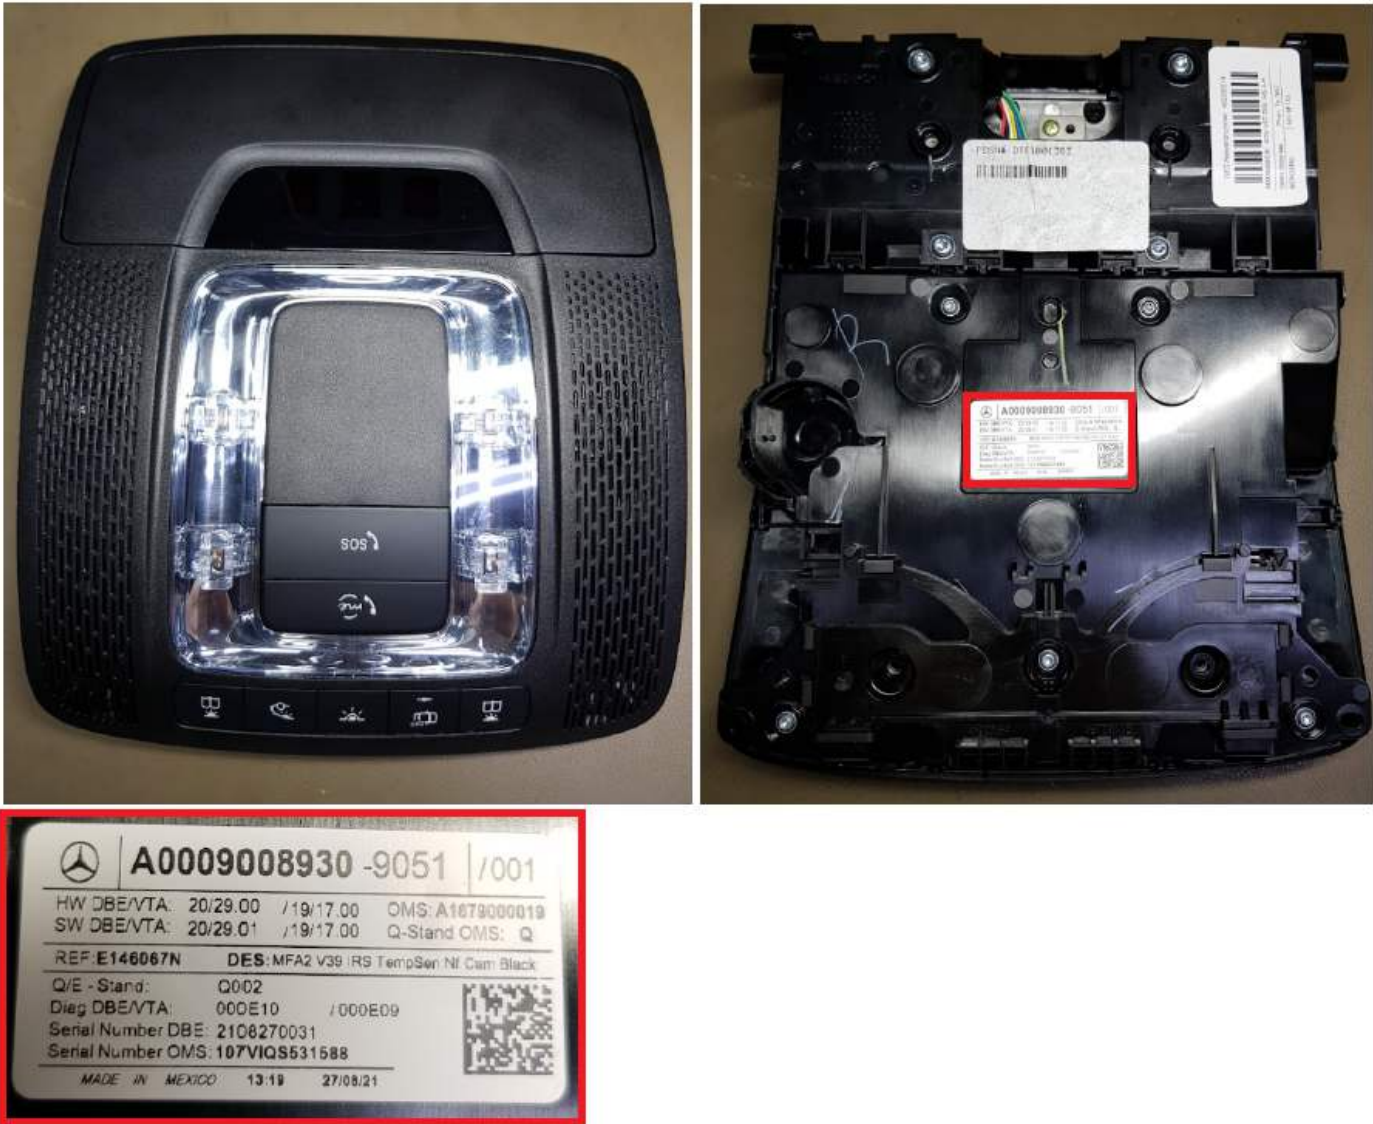
- Attach photo of overhead control panel label (see example images)
- Add control unit log of anti-theft alarm system [N26/6]
- Add alarm history of anti-theft alarm system [N26/6], alarm siren [H3/1] and front signal acquisition and actuation module [N10/6]
