## Technical product information

| <b>Brand</b> | Bentley |
| <b>Transaction No.</b> | 2075034/2 |

EPB Warning light in DIP - Front door/s power latch system intermittent - DTC U112300 within Address 03 and Address 46

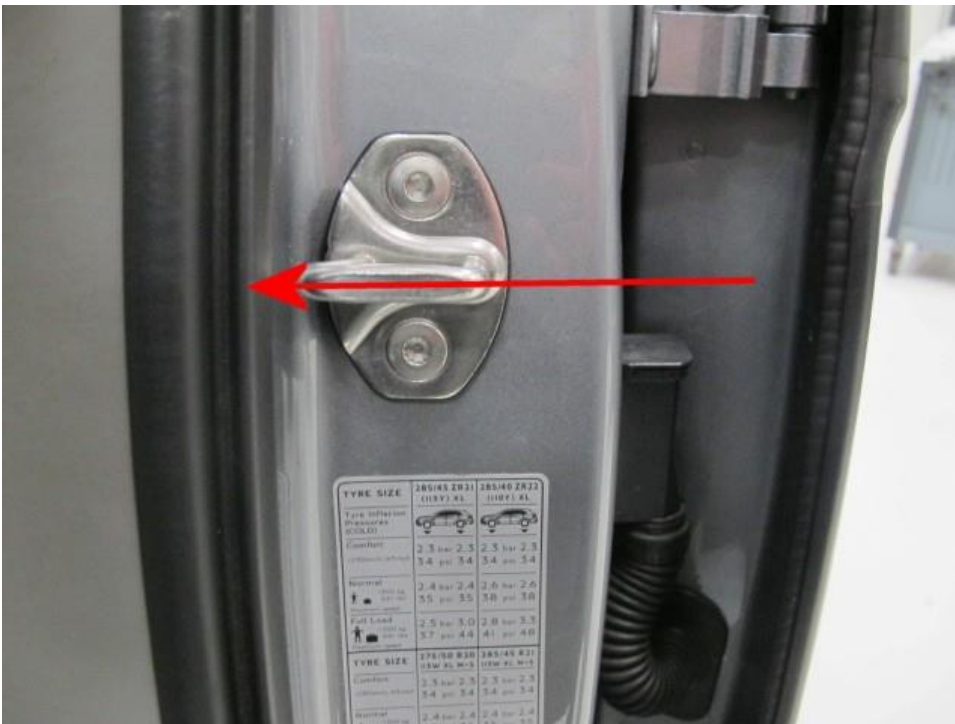
Figure 2

The micro switch signal of the door lock is not recognised or is recognised briefly, a counter press of the door by the operative is required to clearly recognise the signal

Insufficient back pressure of door (door closing loads / seal load) results in the pawl microswitch signal becoming too short. This short signal is then calculated as an error state by address 0003 -Brake electronics

In addition, adjust the striker as far as possible (at least 0.5 mm) further inwards (Figure 2)
