# Technical product information

| Topic | Engine overheating - Warning in the DIP (V8 Kovomo) |
| Brand | Bentley |
| Transaction No. | 2061369/8 |

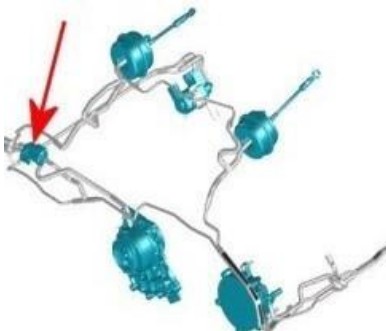
To allow the engine coolant to heat as quickly as possible (from cold start) coolant delivery from the mechanical coolant pump is interrupted by switch valve N649

Figure 1 - Bentayga

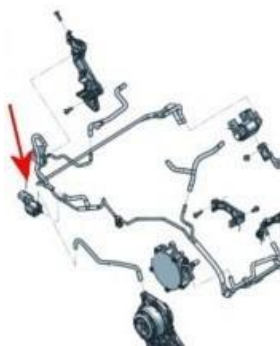
Figure 2 - New Continental GT/ GTC and Flying Spur
