# Service Alert

| <b>Subject:</b><br>MULTIPLE WARNING LIGHTS ON, VEHICLE ONLY STARTS WITH KEY TRANSMITTER NEAR START BUTTON DUE TO POOR CONTACT AT FUSE F1 | <b>Service Alert No.:</b> SA-040/24 |

2024-2025 CX-90  
2025 CX-70

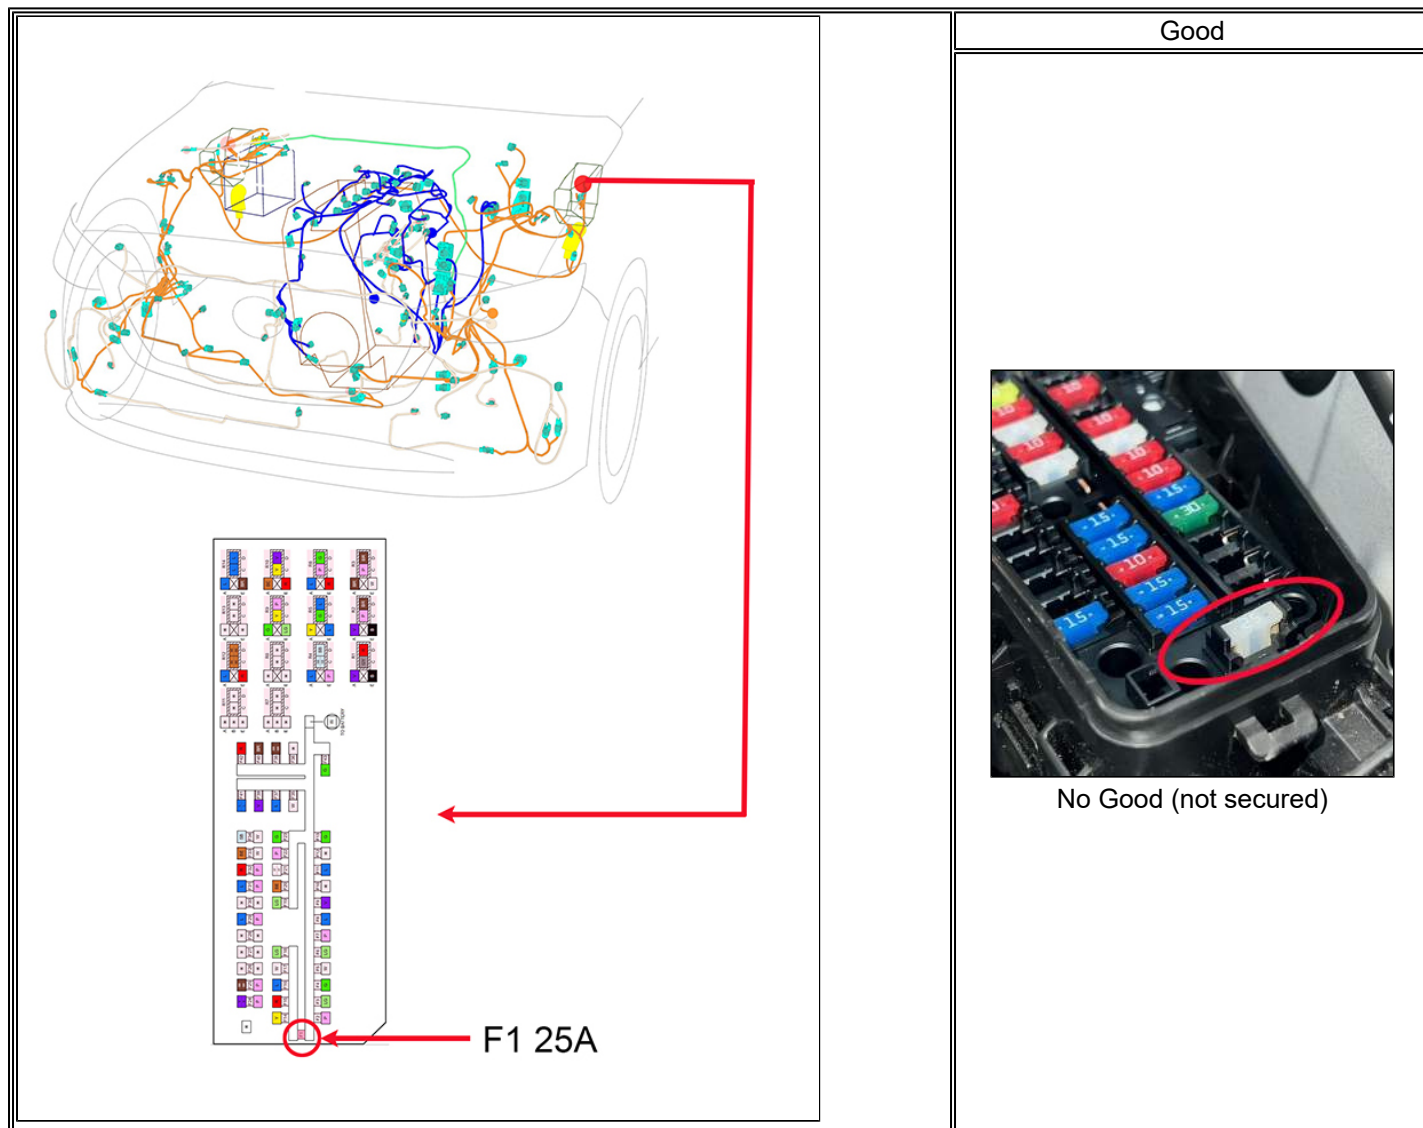
**NOTE:** The F1 25A fuse is removed during transportation. The F1 25A fuse must be inserted completely before the vehicles are delivered to customers.

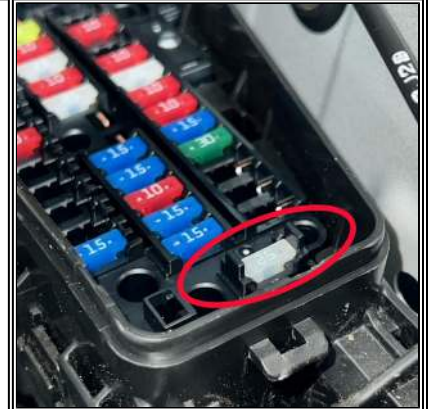
Good

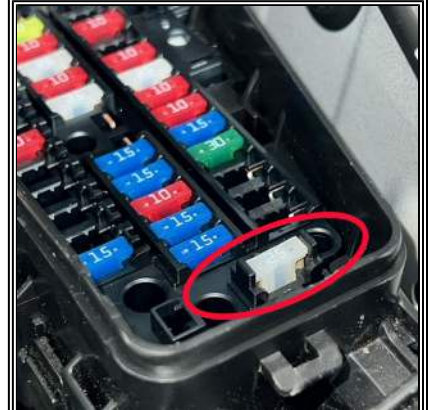
**Is fuse F1 not fully seated or have poor terminal tension?**

**NOTE:** The positioning rib may cause insufficient insertion.

No Good (not secured)

- **Yes** - Secure fuse F1
- **No** - This service information does not apply. Proceed to normal MGSS troubleshooting.

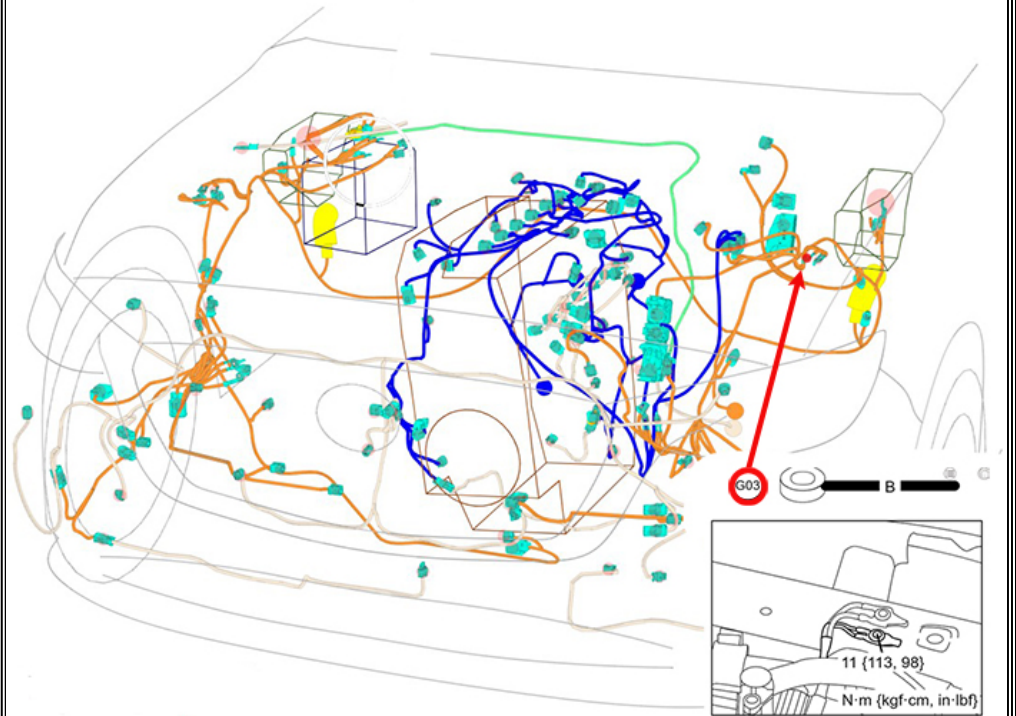
**Is G03 ground connection loose?**

- **Yes** - Secure G03 ground connection.
- **No** - This service information does not apply. Proceed to normal MGSS troubleshooting.
