## SERVICE BULLETIN

**APPLICABILITY:** 2022-24MY BRZ

**NUMBER:** 09-128-24

**SUBJECT:** DTCs P2404, P0016-19, P0021,  
& U0100 Diagnostic Procedures

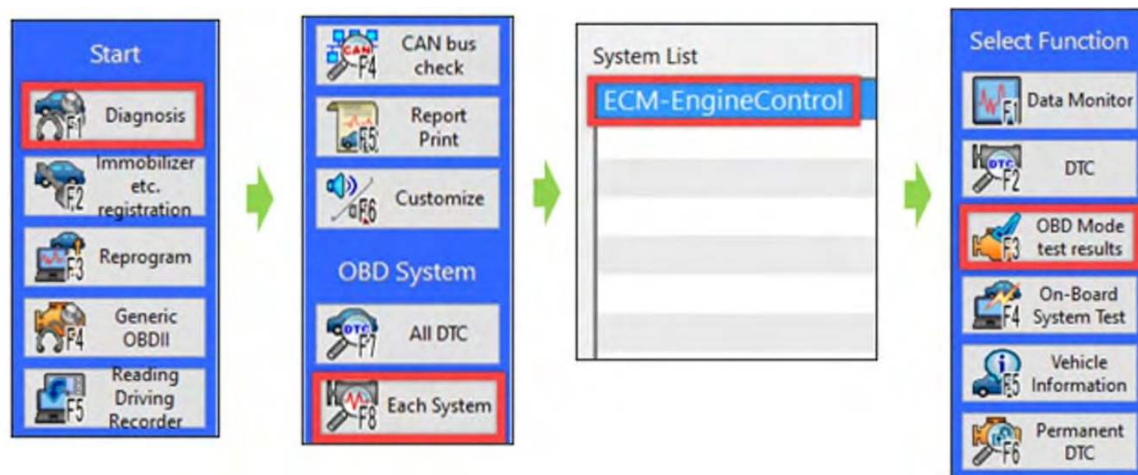
(\*1) **IMPORTANT:** Use the following instructions to perform and read the OBD MODE test results. This procedure will be required when performing the diagnostic steps outlined below.

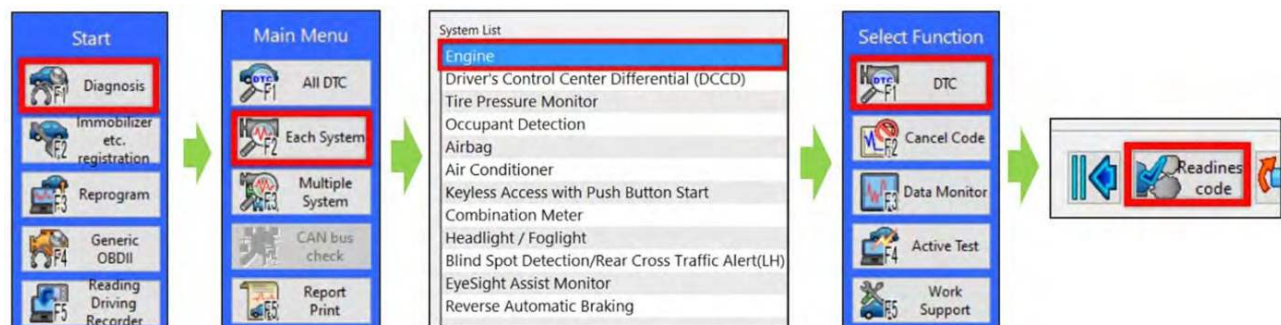
N. Using SSM, select Diagnosis > Each System > Engine > DTC > Readiness Code

- O. Read the readiness codes for P0016, P0017, P0018, P0019, P000A, P000B, P000C, and P000D. Confirm the self-diagnosis is complete and that the codes are not pending.

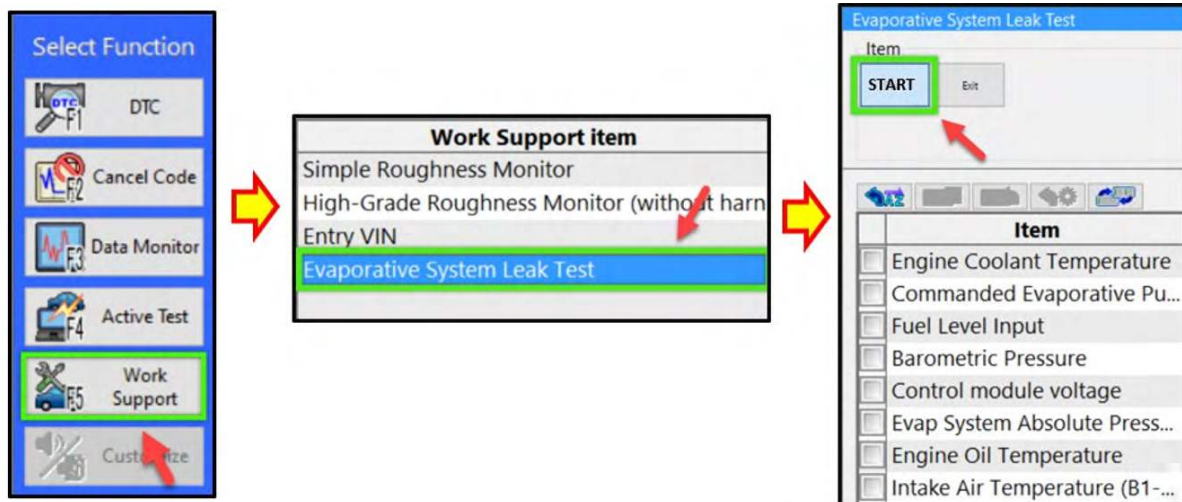
**STEP 6:** Connect the vehicle to a recommended power supply. See **APPENDIX A** for additional information regarding power supply. Using SSM, perform the Evaporative System Leak Test. Collect and save all data.

Once the evaporative system leak test is complete, check the DTCs and examine the vacuum value results. Record the value shown in the row labeled MID: \$3C, TID: \$C4, and Scaling ID: \$FE. This value should be lower than -0.26 PSI.

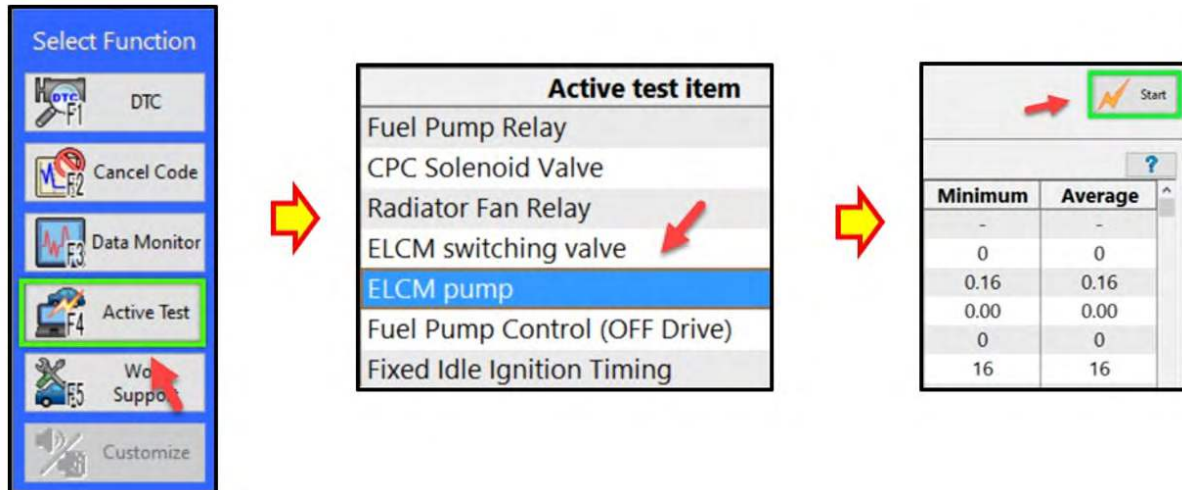
**STEP 8:** Using SSM, perform the ELCM Pump Active Test for a period of 35 minutes or more. See **APPENDIX A** for additional information regarding power supply.

Once the ELCM Pump Active Test has been performed for a period of 35 minutes or more, repeat the Evaporative System Leak Test outlined in STEP 6. Check the DTCs and the vacuum value results.
