## SERVICE BULLETIN

**APPLICABILITY:** 2023-24MY Ascent  
2023-24MY Legacy & Outback

**NUMBER:** 07-225-24R

**SUBJECT:** EyeSight Reprogramming Files / DTCs B28C7, B28A6, Halt Code E5

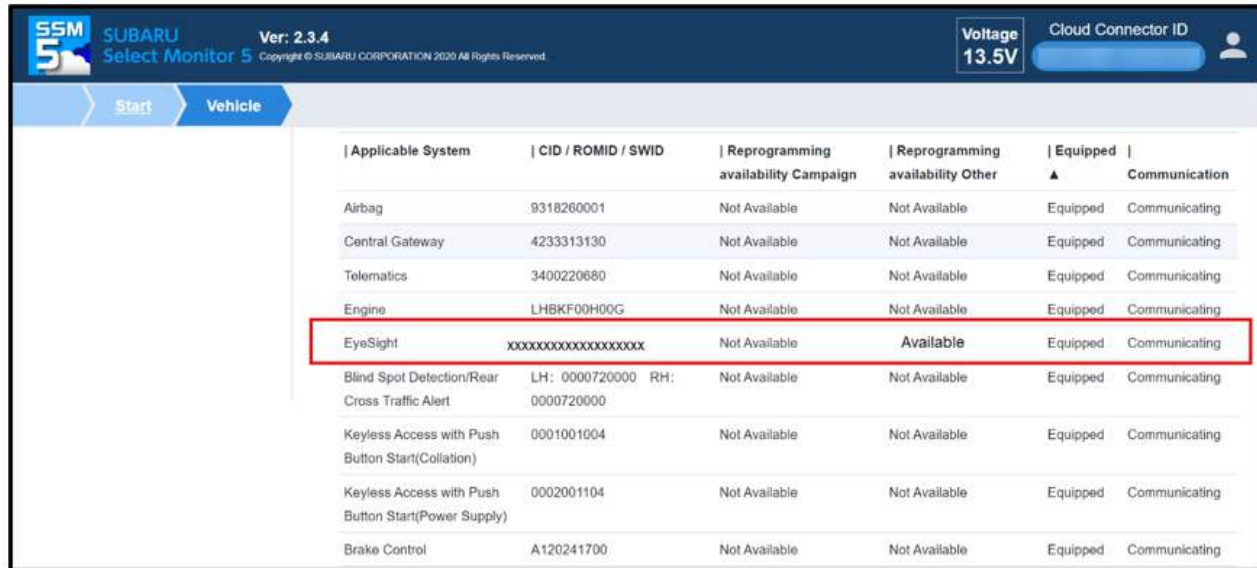
**STEP 5:** Using the Subaru Select Monitor 5-R (SSM5-R), confirm the following EyeSight Stereo Camera Assembly information:

- The reprogramming column reads “**Available.**”

**STEP 7:** Reprogram the EyeSight Stereo Camera Assembly following the normal SSM5-R procedure and confirm the CID/ROMID/SWID has changed to the following:

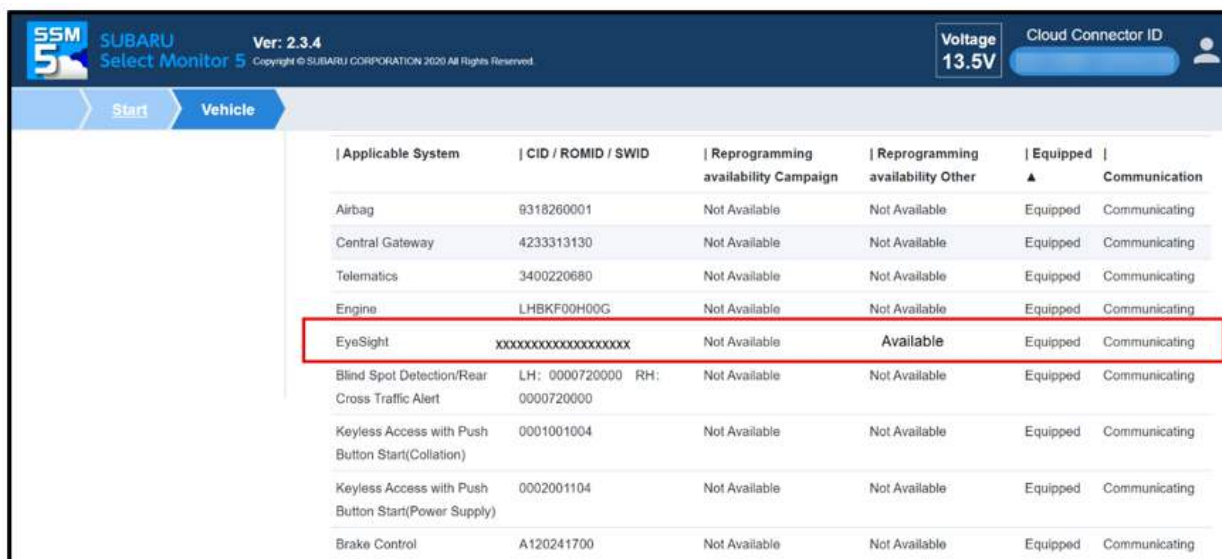
**STEP 4:** Using the Subaru Select Monitor 5-R (SSM5-R), confirm the following EyeSight Stereo Camera Assembly information:

- The reprogramming column reads “**Available.**”

**STEP 6:** Reprogram the EyeSight Stereo Camera Assembly following the normal SSM5-R procedure and confirm the CID/ROMID/SWID has changed to the following:
