## Technical product information

| <b>Topic</b> | New Continental GT and GTC - Window drop glass operation |
| <b>Transaction No.</b> | 2070497/9 |

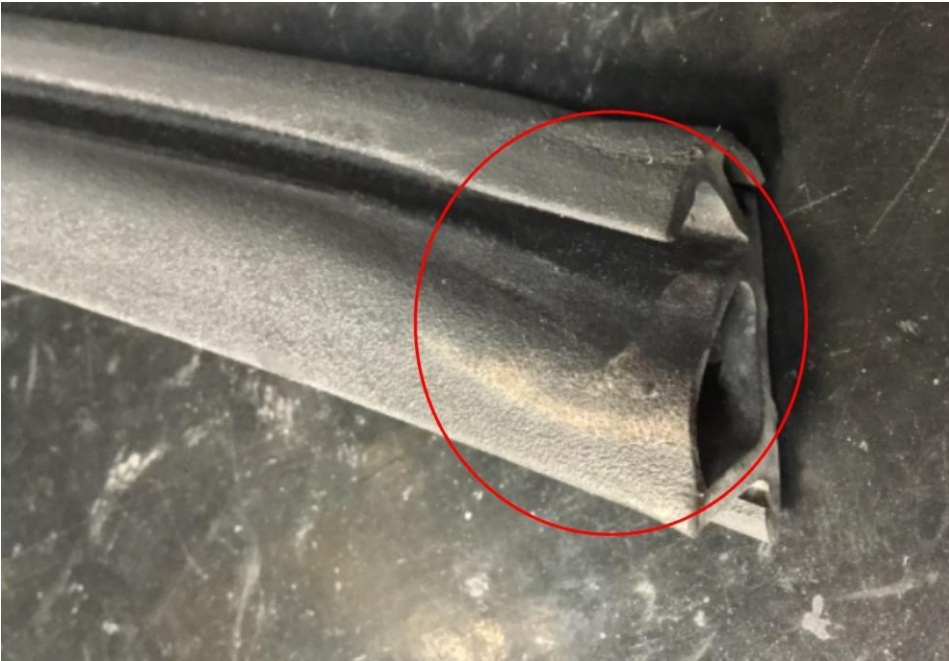
Figure 7

- Incorrectly fitted / located
- Drop glass seal deformation (see Figures 7 and 8 as examples)

**NOTE:** Any issues found with the window seals must be rectified before conducting the remaining steps
