## Check engine warning light active - Fault P300CA8 or P300CA9 "Hot film mass air flow sensor malfunction" present in engine control unit

| Topic number | LI14.30-N-075882 |
| Function group | 14.30 - Secondary air injection |
| Validity | Model 907 with engine 654 |

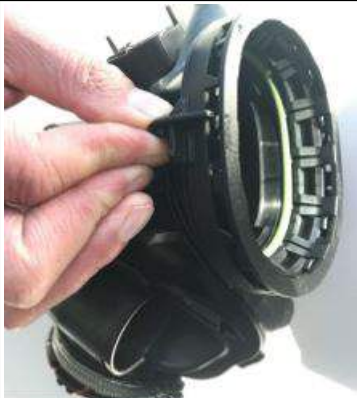
| Attachments | |
|---|---|
| <a href="#">2b.JPG</a> | |

- Relevant area of right-hand clean air line to center clean airline (quick-release coupling - Picture 2a), Observe the following operation steps:
- Operate connector coupling as far as the end stop rib “open position” (Picture 2b).
- Hold connector coupling open until the left-hand clean airline is pushed into the connector coupling as far as the end stop and lies flush all around (Picture 2c).
- Release connector coupling and actively slide it back to the “closed position.”
- Check correct seating of the clean air line using the lock position. If the lock position is not visibly reached (Picture 2d), the clean airline must be repositioned.
- Check the seal between the turbocharger and clean airline for damages. When disassembling that connection point, always replace the sealant ring.

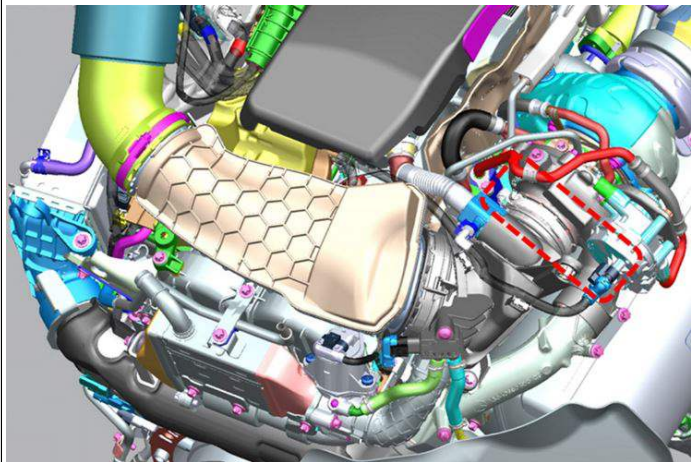
1a.JPG

- Check connection between the exhaust gas turbocharger and the right-hand clean air line. As well as between the right-hand clean air line and center clean air line which has a quick-release coupling.
- Relevant area of exhaust gas turbocharger to the right-hand clean airline (Picture 1a):

Information: When conducting repairs and assembly work, ALWAYS replace the seal in this area.

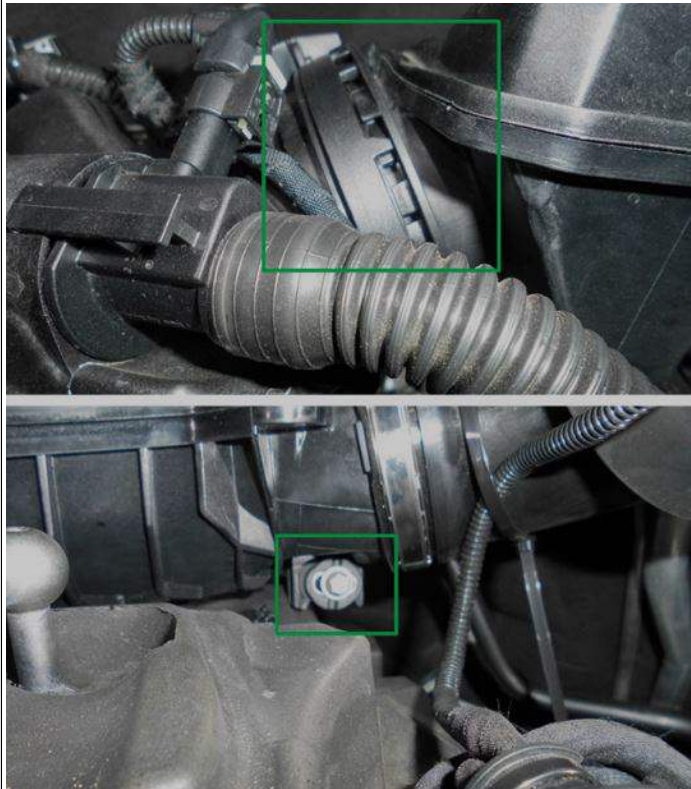
3.JPG

For example images of correct and incorrect installation, (Picture 3) and (Picture 4).
