# Technical Service Bulletin

## 01 MIL on, Whistling noise, leaking air Bank 2 - DTC P2ADF00, Engine Crankcase breather

01 24 42 2071318/5 October 8, 2024. Supersedes Technical Service Bulletin Group 01 number 23-92 dated November 6, 2023 for reasons listed below.

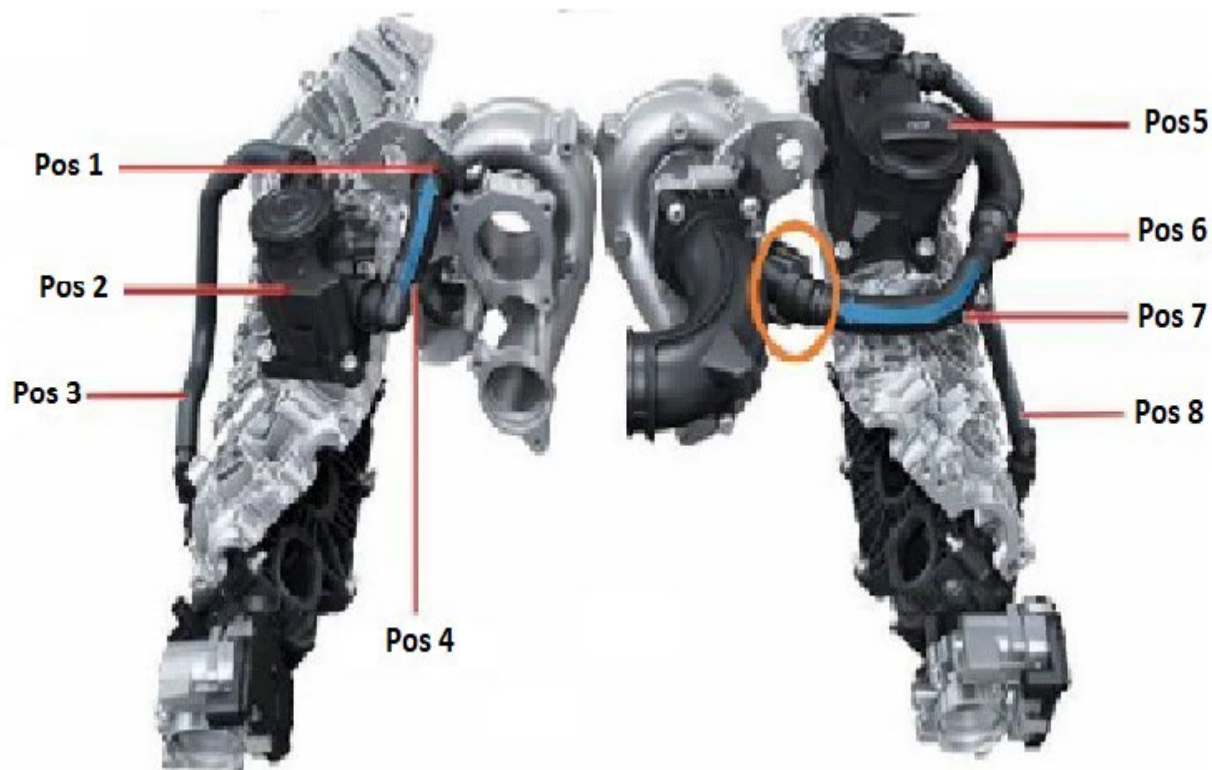
Below is an illustration of the crankcase breather from the SSP 676/ SSP 920493.

- Item 1: Non-return valve
- Item 2: Oil separator for bank 1

- Item 3 Part load breather line for bank 1
- Item 4: Full load breather line for bank 1
- Item 5: Oil separator for bank 2
- Item 6: Non-return valve (*Not applicable for engine codes CWWB, and DWKA, because Non-return valve is integrated into the intake manifold*)
- **Item 7: Full load breather line for bank 2**
- Item 8: Part load breather line

In this case, replace the full load breather line for **cylinder bank 2**. Do not replace the oil separator for bank 1 and bank 2 or the part load breather lines. Please note that the connection for the full load breather line (cylinder bank 2) to the air pipe (see orange marking in illustration below) is a “not to open” connection. This means that the full breather line (bank 2) cannot be detached from the air pipe without being irreparably damaged. Please note the relevant information in the Workshop Manual (chapter: Engine Lubrication/ crankcase breather).
