# Technical Service Bulletin

## 34 Function restriction with event memory entry P071800 - P276800 (symptom 20736 - 20737)

34 24 72 2067653/9 October 24, 2024. Supersedes Technical Service Bulletin Group 34 number 24-69 dated July 3, 2024 for reasons listed below.

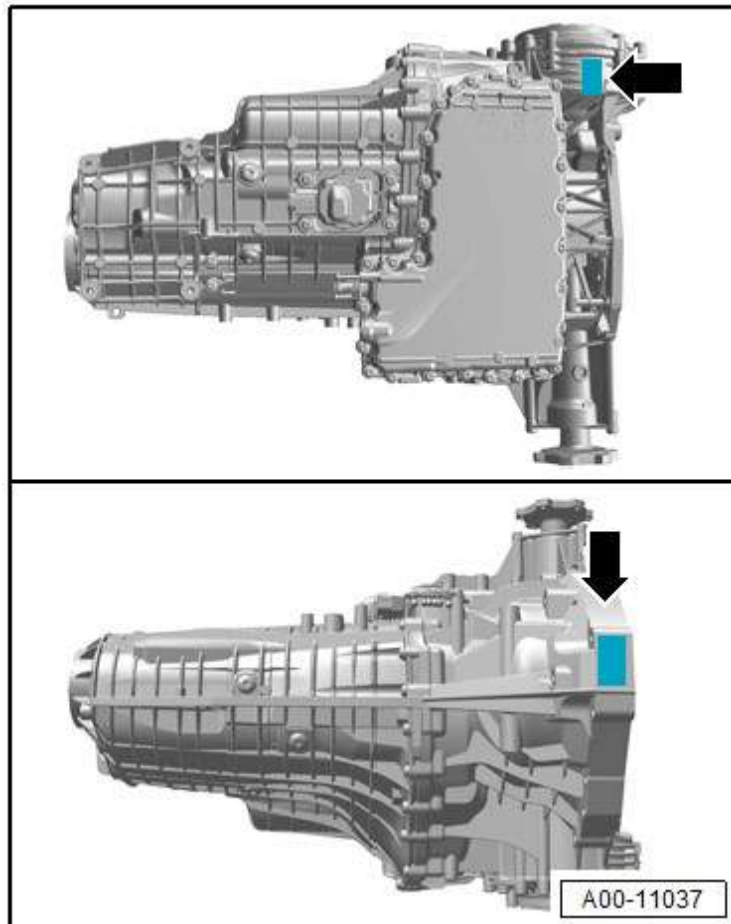
- Check one of the transmission data stamps which are located on the bottom of the front differential and the top of the bell housing (Figure 1).

**Figure 1.** Locations of data stampings.
