# Technical Service Bulletin

## 93 A7/Q5 PHEV Gearbox: drive system fault displayed in instrument cluster (P0A4000)

93 24 20 2074662/2 October 1, 2024. Supersedes Technical Service Bulletin Group 93 number 24-01 dated July 31, 2024 for reasons listed below.

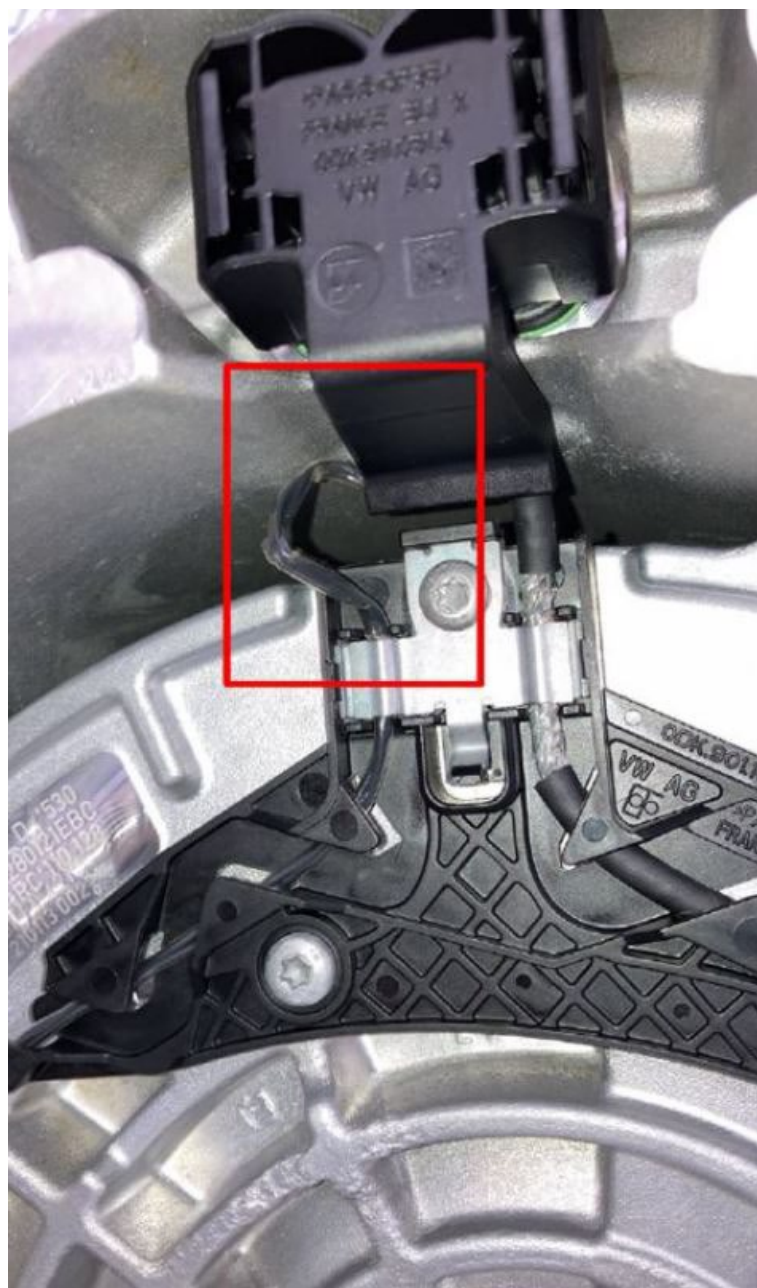
**Please work with great care when installing the rotor position sensor so that the sensitive wires on the gearbox housing are positioned correctly.**

**Figure 1.** Wire not fitted correctly

If DTC **P0A4000** with symptom 50954 is present as the only fault in the electric drive control unit J841 (diagnostic address 0051), replace the drive motor position sender 1 G713 (rotor position sensor) according to ELSA.

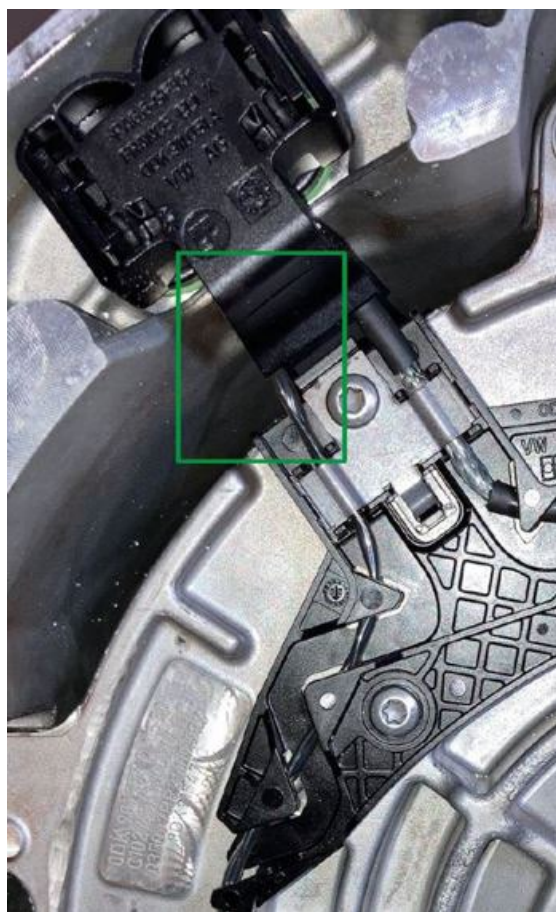
**Figure 2.** Installation according to Workshop Manual
