| DTC U010087 & No Start / Replaced Engine ECU After Jump Starting | | USA |
| Engine/Hybrid System | Engine Control | |
| Lexus: CONV / HEV - A25A, T24, 2GR | | |

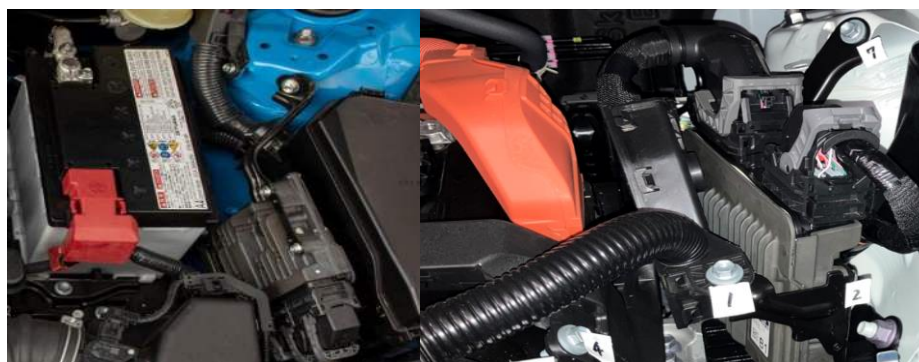
Conventional Engines (Fig. 1)

After jump-starting, the vehicle may experience a no-start condition and multiple DTCs including U010087 - Lost Communication with ECM/PCM "A" Missing Message. Upon investigation, it is found that the engine ECU has been damage and needs to be replaced. In several cases, the cause of the ECU damage was improper jump starting. Further investigation found that ECU damage may occur if the negative (ground) cable clamps are attached on or around the engine ECU or mounting bracket. Please refer to (Fig. 1 and 2) for risk point locations on Conventional and HEV engines.

To prevent this condition from occurring, it is recommended that the jumper cables be attached as described in the owner's manual. Below is an example of the correct jump start locations for 23MY ES250 (Fig 3). Please consult the appropriate owner's or repair manual to confirm the correct jump start location on other models.
