# Service Bulletin

Bulletin No.: 21-NA-192  
Date: October, 2024

**Subject:** Top Not Secure DIC Message, DTC B19E4 SYM64 May be Stored in History in Convertibles

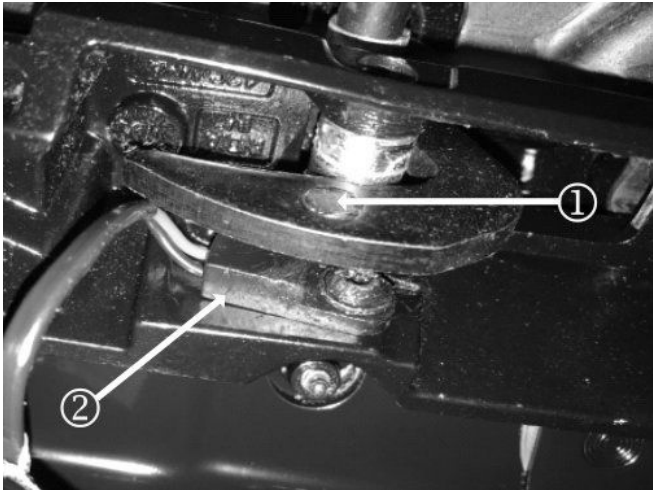
| Cause | <div></div> <p><b>Note:</b> This hall effect sensor (2) is looking for the magnet (1) to be in alignment. It has an invisible hemispherical sensor zone.</p> <p>The cause of the condition is ultimately a misalignment of the roof alignment pin to the receiver in the header. This in turn causes a misalignment of the sensor to the magnet over time.</p> |

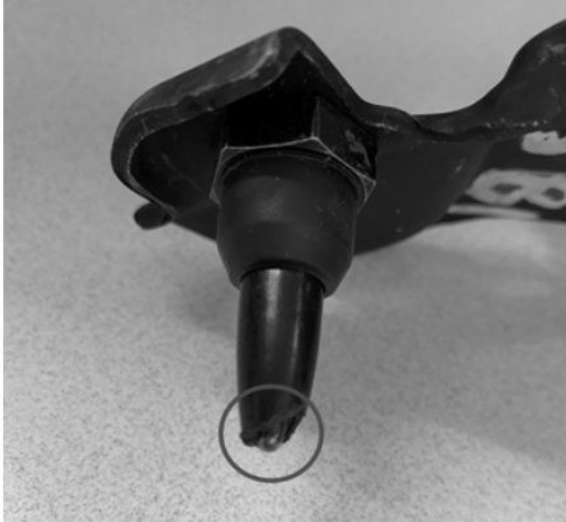
6741889

Additional evidence of a hard-hitting top with poor pin alignment will be a broken pin tip:

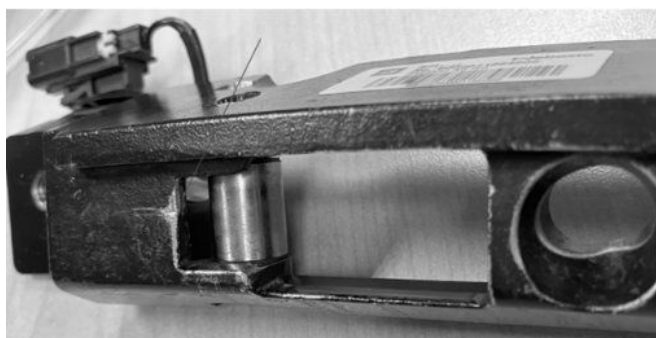
6741891

3. Locate the right side folding top front striker and check for a witness mark as shown in the image above with the red arrow. If there are signs of damage with missing paint, then it is likely the top will need an adjustment to the latch carrier plate. This procedure is described later in this document.

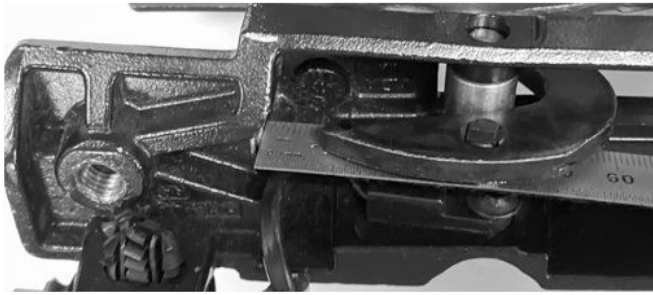
6741894

6. With the top closed, measure the distance from the tip of the latch hook to the nearby inboard vertical edge as shown in the image. You may need to pre-position your ruler if the hook automatically retracts and ask someone to operate the top so you can perform the measurement. The nominal position should be 5 mm when the magnet and hall-effect sensor are aligned. This will be the target position to achieve by performing the following adjustments.
7. Retract the top part way to gain easy access to the front roof panel and remove the headliner. Between top movements, turn off the ignition to conserve 12-volt battery power.
