2011-2013MY  
Sportage (SL)  
w/Theta 2.4L MPI

PI2103Y/Z (Rev 1, 11/07/2024)

ENGINE REPLACEMENT INSTRUCTIONS  
FOR DTC P1326 (PI2103Y/Z)

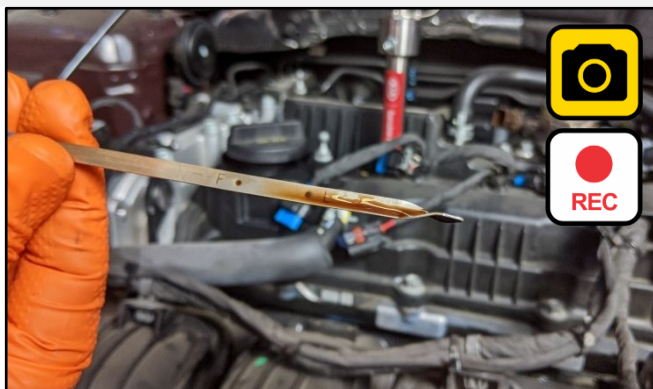
1. Start video showing vehicle and move in towards the dash VIN tag.
2. Measure and record oil dip stick level.
3. Note oil dip stick reading on the RO.
4. Take a picture of the oil reading on dipstick.

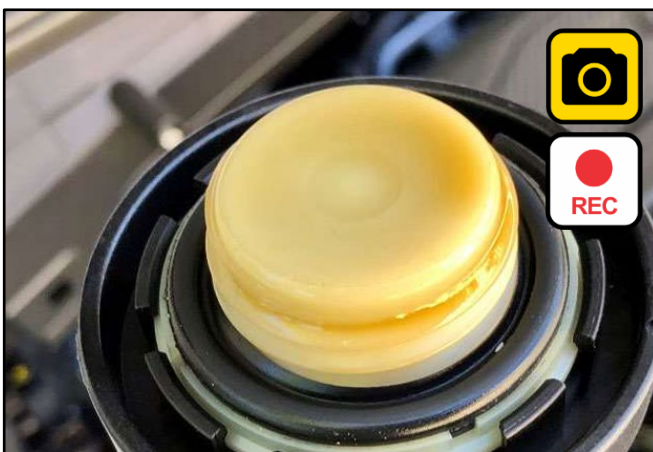
5. Inspect the inner/bottom of the oil cap and inside oil filler opening.

6. Take a picture of both, the bottom of the oil cap and oil filler opening.

**Record/Note findings:** No oil, oil sludge, varnish, burnt oil smell condition(s) found.

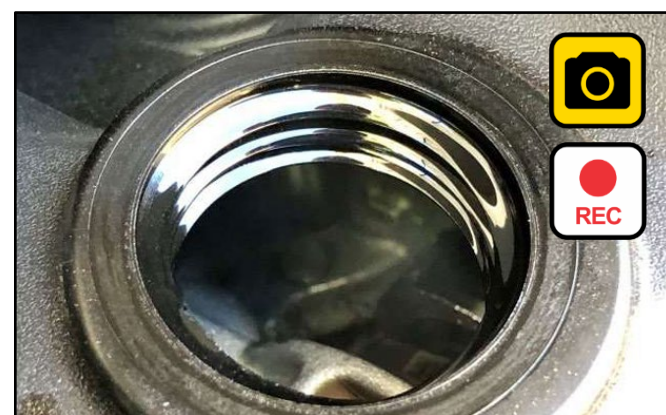
**If NO oil is registered on the dipstick, or oil lacquering, oil sludge and/or oil varnish is present (NG), then the engine is therefore suspect to maintenance neglect.** Review of the vehicle's maintenance history is required.

**If suspect,** proceed to the 'Oil Level Measurement' instructions below and submit with the Techline case.

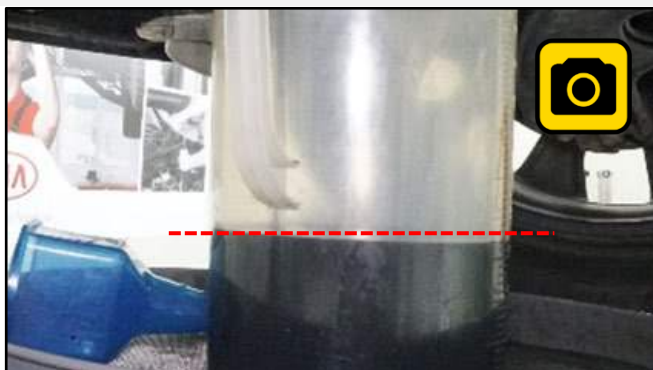
**Oil Level Measurement: (Main Flowchart → PWA Request) NO OIL READING ON DIPSTICK**

1. Remove oil filler cap, remove oil drain plug and drain oil into the measuring container SST067BUCK and check oil level.
2. Record oil level reading on the RO.
3. Take photo of the drained oil container using KDS and attach to warranty claim PWA request.

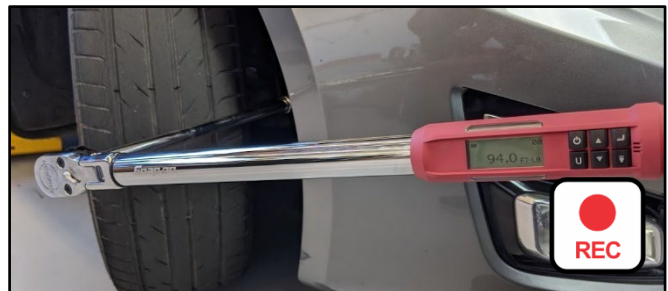
6. Show the engine being cranked and torque specification exceeding 94 lb.ft. torque.
