2017-19MY  
Soul (PS)  
w/Nu 2.0L GDI

PI2107Y/Z (Rev 1, 11/07/2024)

ENGINE REPLACEMENT INSTRUCTIONS  
FOR DTC P1326 (PI2107Y/Z)

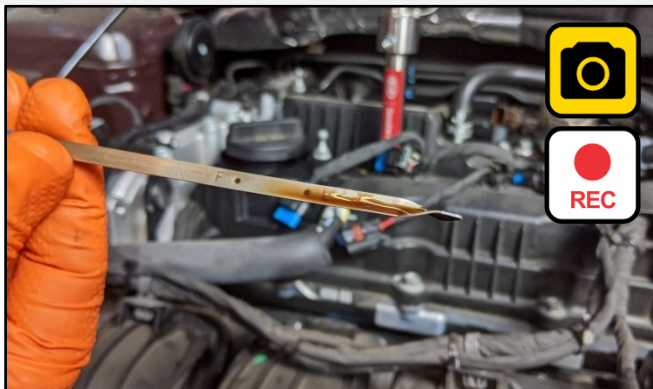
1. Start video showing vehicle and move in towards the dash VIN tag.
2. Measure and record oil dip stick level.
3. Note oil dip stick reading on the RO.
4. Take a picture of the oil reading on dipstick.

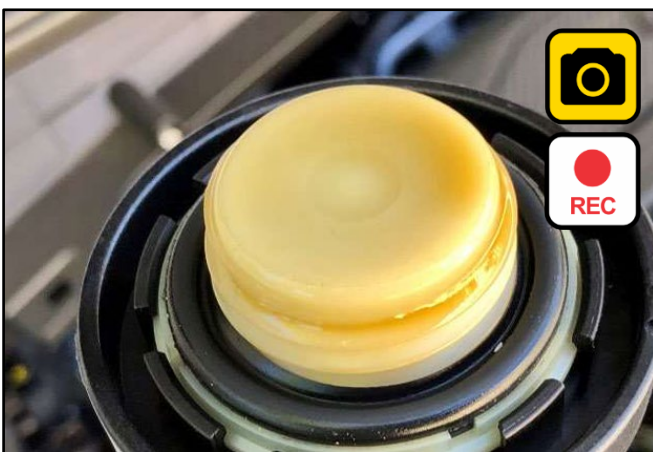
5. Inspect the inner/bottom of the oil cap and inside oil filler opening.

6. Take a picture of both, the bottom of the oil cap and oil filler opening.

**Record/Note findings:** No oil, oil sludge, varnish, burnt oil smell condition(s) found.

If NO oil is registered on the dipstick, or oil lacquering, oil sludge and/or oil varnish is present (NG), then the engine is therefore suspect to maintenance neglect. Review of the vehicle's maintenance history is required.

If suspect, proceed to the 'Oil Level Measurement' instructions below and submit with the Techline case.

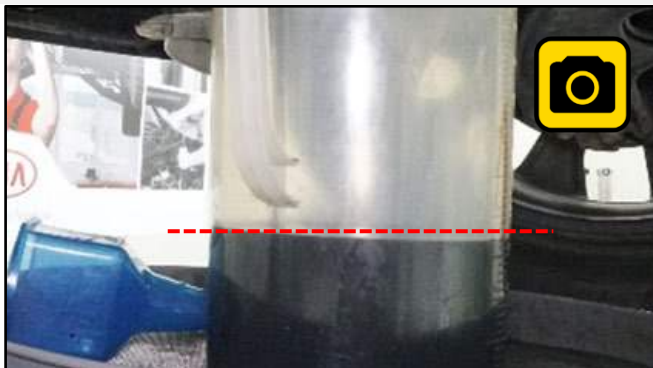
**Oil Level Measurement: (Main Flowchart → PWA Request) NO OIL READING ON DIPSTICK**

1. Remove oil filler cap, remove oil drain plug and drain oil into the measuring container SST067BUCK and check oil level.
2. Record oil level reading on the RO.
3. Take photo of the drained oil container using KDS and attach to warranty claim PWA request.

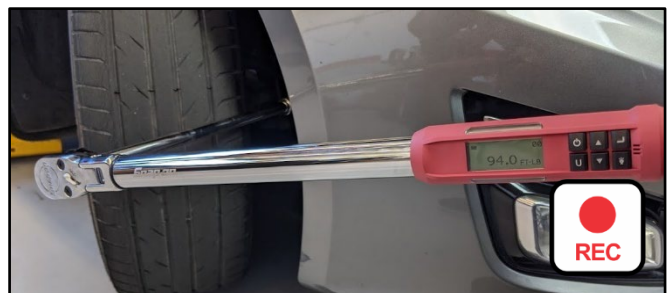
6. Show the engine being cranked and torque specification exceeding 94 lb.ft. torque.
