## STAR ONLINE PUBLICATION

**Case Number:** S2423000049

**Symptom/Vehicle Issue:** Blind Spot Warning Displayed On Instrument Cluster. Mid Range Radar Left And Or Right Setting C00C4-76 C00C5-76 Rear Radar Module Wrong Mounting Position.

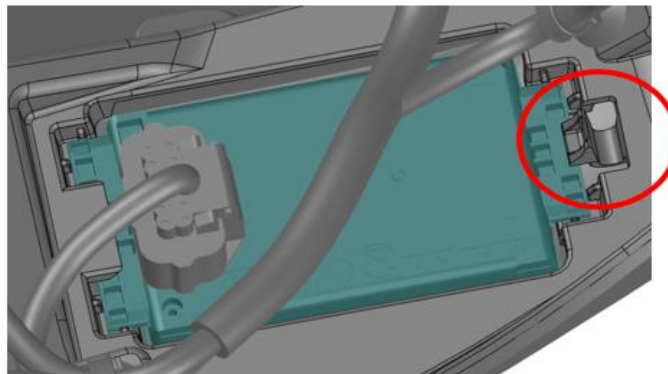
Fig 2

Inspect the Mid Range Radar (MRR) retention snap clip. If the clip is not securing the MRR or the MRR is found not fully snapped in place, use hand pressure to fully seat the module (Fig 2).
