# Service Bulletin

Bulletin No.: 24-NA-145  
Date: October, 2024

**Subject:** Malfunction Indicator Lamp (MIL) Illuminated - DTC P219A Set as Current or History

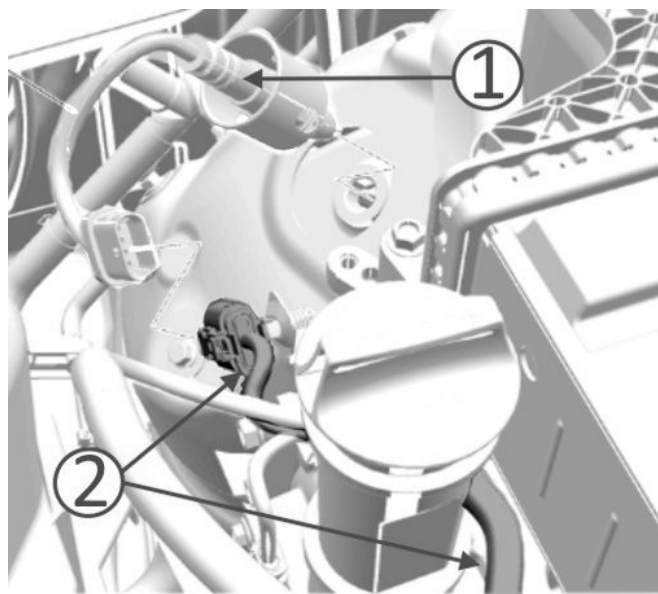
6709693

**Note:** The wiring from the PCM X3 connector cavity 48 routes to cavity 3 and cavity 49 routes to cavity 4 in the HO2S connector.

1. Disconnect the battery negative cable.
2. Remove the Air Cleaner Outlet Duct. Refer to *Air Cleaner Outlet Duct Replacement* in SI.
