# Technical Service Bulletin

## 01 Turbocharger: Adjustment unit for turbocharger; P256300, P056E00, P00AF00

01 24 44 2075010/2 November 25, 2024. Supersedes Technical Service Bulletin Group 01 number 24-39 dated September 26, 2024 for reasons listed below.

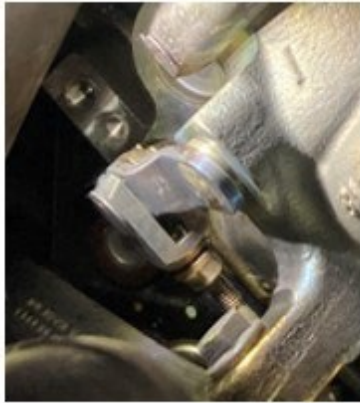
*Figure 1. Turbocharger adjustment unit close-up.*

- Spray the turbocharger adjustment unit with rust remover,
- Try to loosen the adjustment unit using the final control diagnosis.
- If this is not possible, continue with the steps listed under “with turbocharger removed.”

- Removed the turbocharger as described in the workshop manual.
- With the turbocharger removed, attempt to restore the function of the turbocharger adjustment unit with workshop materials (rust remover, pliers, etc.).
- Then lubricate the fork joint with high temperature paste G052112A3.
- Install the turbocharger as described in the workshop manual.
- Perform final control diagnosis.

- The turbocharger must be replaced if it is not possible to loosen the turbocharger linkage. Lubricate the new fork joint with high temperature paste G052112A3.

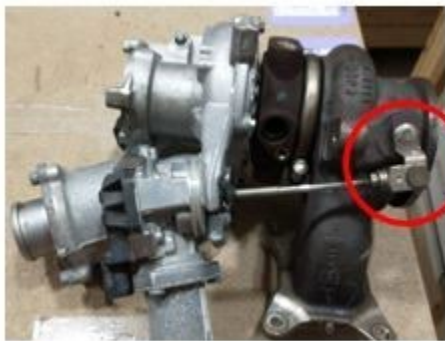
*Figure 2. Turbocharger adjustment unit.*
