# Technical Service Bulletin

## 42 Booming noise from rear area while vehicle is moving (depending on vehicle speed/wheel speed) DTC P18F100

42 24 58 2068250/3 November 11, 2024. Supersedes Technical Service Bulletin Group 42 number 23-52 dated June 6, 2023 for reasons listed below.

| Model(s) | Year | VIN Range | Vehicle-Specific Equipment |
|---|---|---|---|
| Q4 e-tron, and Q4 Sportback e-tron | 2022 - 2025 | All | Not Applicable |

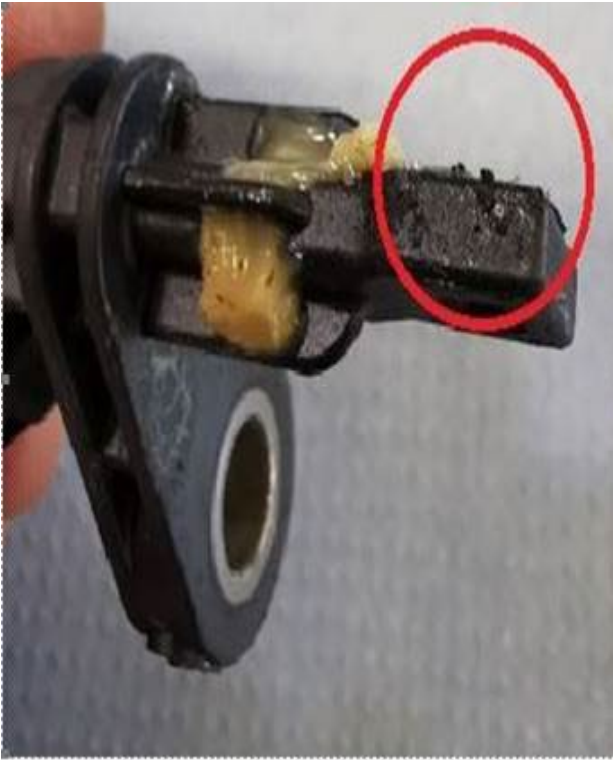
Foreign metallic particles in the area of the wheel speed sensor/wheel hub/wheel bearing/drive shaft (see figure 1, red circle) lead to implausible wheel speed signals.

**Figure 2:** *Metallic particles in the speed sensor.*

1. Check components for foreign metallic particles:
2. Remove foreign metallic particles, check components for damage, and replace components if necessary.

- Thoroughly remove foreign metallic particles from the components with workshop materials.

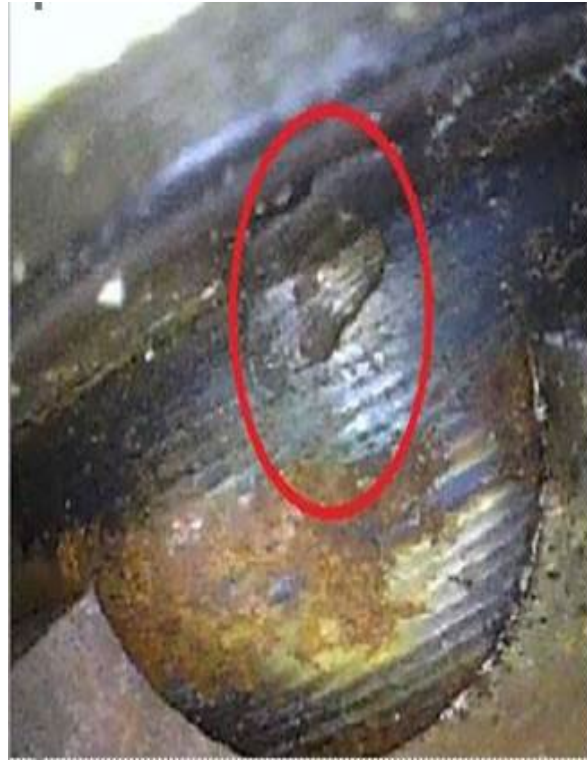
**Figure 3:** *Metallic particles in the hub.*

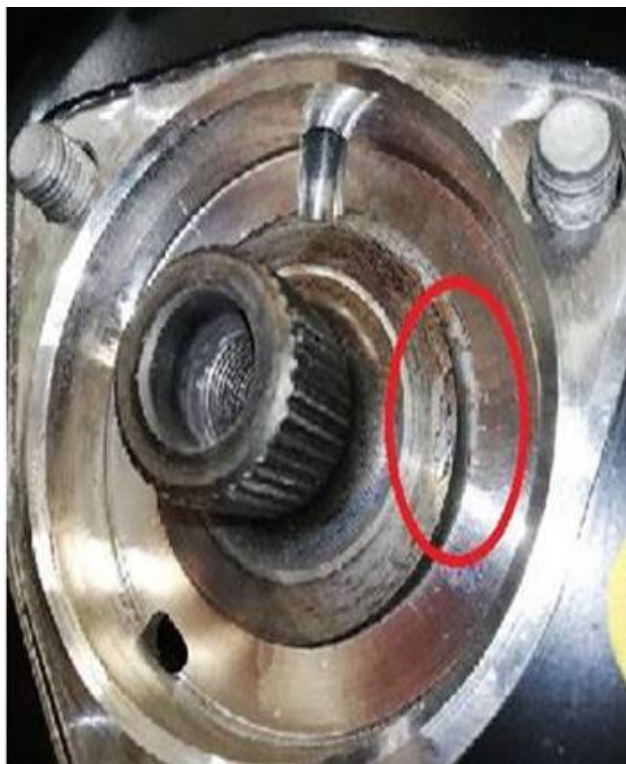
**Figure 4:** Metallic particles/damage in the wheel hub/bearing.

- If there is damage to the components, the corresponding components must be replaced according to ELSA/ETKA).
- Finally, delete the DTCs.

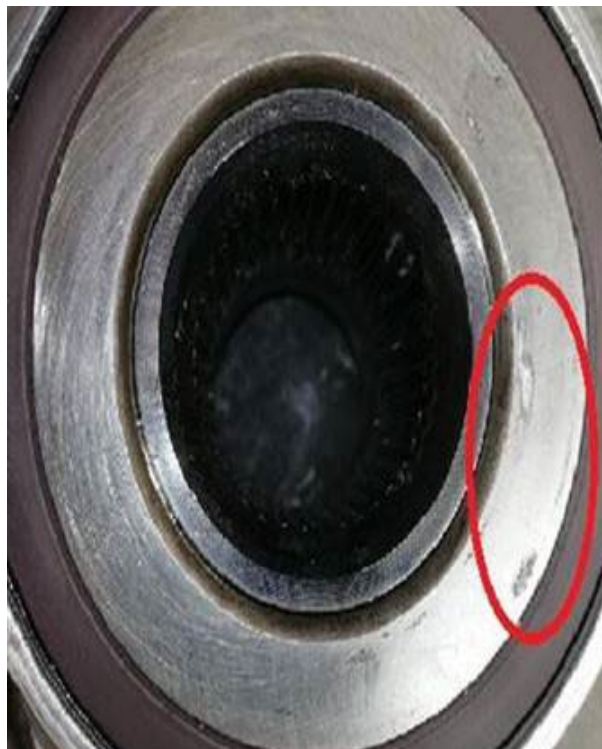
**Figure 5:** Metallic particles/damage in the wheel hub/bearing.
