# Technical Service Bulletin

## 42 Booming noise from rear area while vehicle is moving (depending on vehicle speed/wheel speed) DTC P18F100

42 24 59 2068250/4 November 21, 2024. Supersedes Technical Service Bulletin Group 42 number 24-58 dated November 11, 2024 for reasons listed below.

| Model(s) | Year | VIN Range | Vehicle-Specific Equipment |
|---|---|---|---|
| Q4 e-tron, and<br>Q4 Sportback e-tron | 2022 – 2025 | All | Not Applicable |

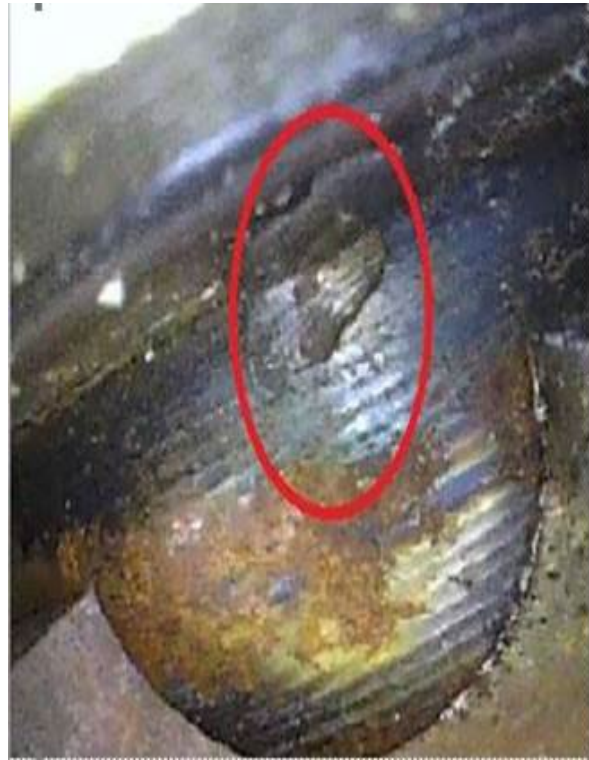
**Figure 3:** *Metallic particles in the hub.*

- Thoroughly remove foreign metallic particles from the components with workshop materials.

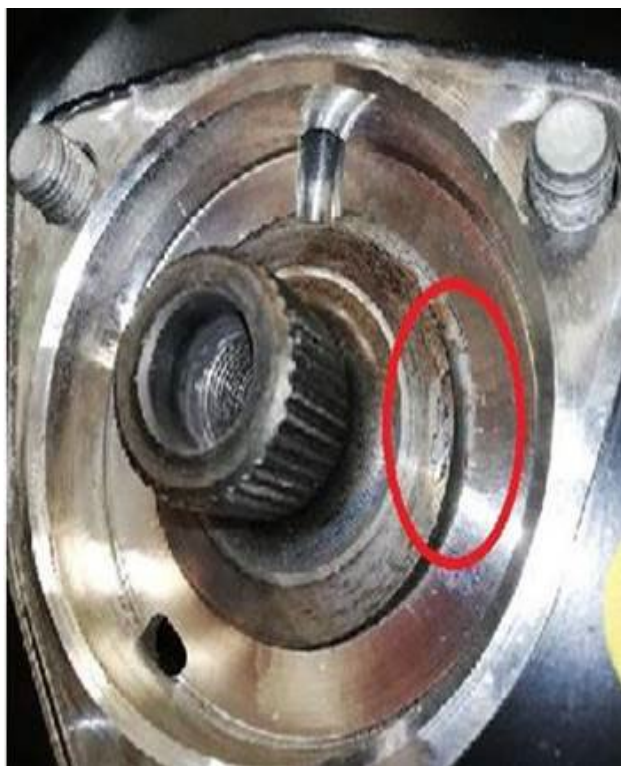
**Figure 4:** Metallic particles/damage in the wheel hub/bearing.

- If there is damage to the components, the corresponding components must be replaced according to ELSA/ETKA).
- Finally, delete the DTCs.
