# Technical Service Bulletin

## 69 Airbag warning light on, DTC B120E1B

69 24 19 2072023/2 November 22, 2024. Supersedes Technical Service Bulletin Group 69 number 23-02 dated November 15, 2023 for reasons listed below.

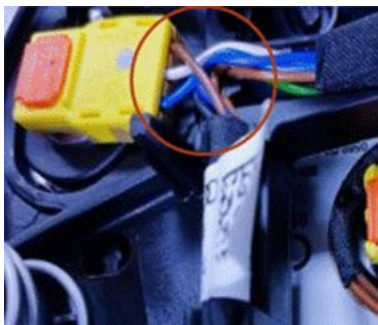
Non-optimal wiring routing causes tension on the release valve connector. This leads to increased resistance during vibrations, which results in an event memory entry being logged.

*Figure 2. Check the routing of the wiring inside the driver airbag.*

3. Replace the airbag wiring harness. Make sure that you route the wiring in such a way that it does not create tension.
