# Technical Service Bulletin

## 93 PSS Q8 e-tron: Charging flap module without search illumination; P33E300; B1A8AF3

93 24 27 2073481/4 November 4, 2024. Supersedes Technical Service Bulletin Group 93 number 24-61 dated June 28, 2024 for reasons listed below.

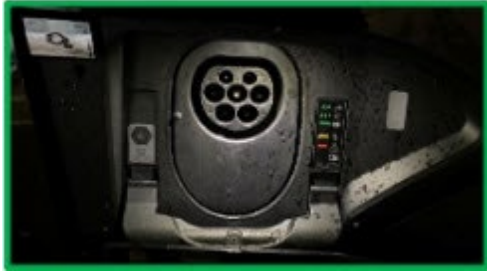
If the vehicle is equipped with both charging flap modules (left and right) the lighting is active and functions as designed.

*Figure 1: Vehicle with functioning orientation light in the charging flap module.*

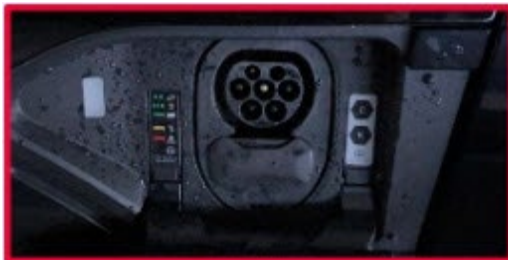
If the vehicle is only equipped with single charging flap module the orientation light does not work. An error in the OBC (00C6) software means that the orientation light LED is not activated when the vehicle is equipped with only one charging flap module.

*Figure 2: Vehicle with a non-functioning orientation light in the charging flap module.*

1. Explain to the customer that a solution is expected to be available by the end of the 4th quarter of 2024 (subject to change) and that no repairs are necessary at this point.
2. Do not replace any components for this condition since this will not resolve the customer's concern.
3. Create a PSS record in the PSS application through the Pending Service Solutions (PSS) link in AccessAudi (under *Related Links >> Service*).
