# Technical Service Bulletin

## 96 High beam assist or traffic sign detection limited, DTC C12B3FD may be stored in the DAS control module

96 24 11 2059201/8 November 20, 2024. Supersedes Technical Service Bulletin Group 69 number 23-01 dated November 15, 2023 for reasons listed below.

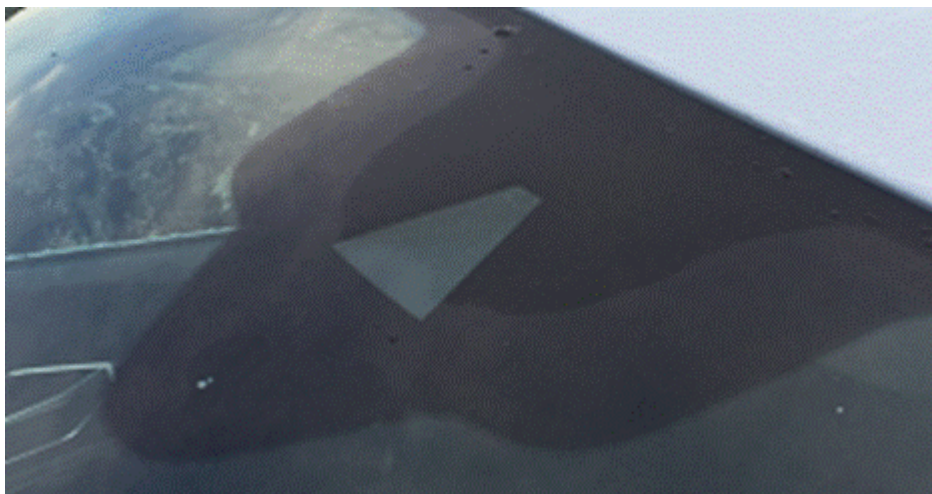
**Figure 1.** Viewing area fogged up from outside.

3. The customer cannot see this from the interior of the vehicle. Often it is enough to switch on the wiper system to fix the concern.
4. If the front camera is fogged up from the inside regularly, it can help to remove its lens hood in order to clean and dry the viewing area of the camera.

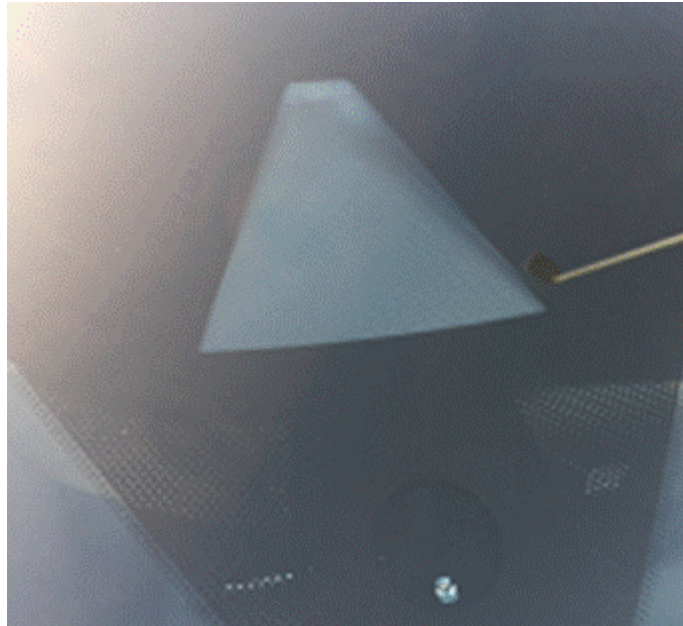
**Figure 2.** Viewing area fogged up from inside.
