| DTC U010087 & No Start / Replaced Engine ECU After Jump Starting | | USA |
| Engine/Hybrid System | Engine Control | |
| Lexus: CONV / HEV - A25A, T24, 2GR | | |

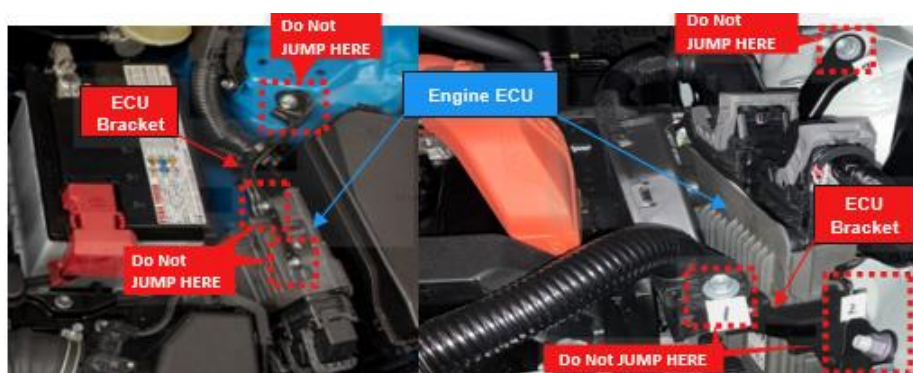
After jump-starting, the vehicle may experience a no-start condition and multiple DTCs including U010087 - Lost Communication with ECM/PCM "A" Missing Message. Upon investigation, it is found that the engine ECU has been damage and needs to be replaced. In several cases, the cause of the ECU damage was improper jump starting. Further investigation found that ECU damage may occur if the negative (ground) cable clamps are attached on or around the engine ECU or mounting bracket. Please refer to (Fig. 1 and 2) for risk point locations on Conventional and HEV engines.
