## Technical Service Bulletin (TSB) Power Transfer Unit (PTU) Failure

| REFERENCE: | TSB: 21-057-24<br>GROUP: 21 - Transmission and Transfer Case | Date: | December 13, 2024 | REVISION: | — |
| VEHICLES AFFECTED: | 2021 - 2024 (M6) Jeep Compass<br>2023 - 2024 (H6) Jeep Meridian<br>This bulletin applies to: <ul style="list-style-type: none"><li>M6 vehicles built on or after December 23, 2020 (MDH 1223XX)</li></ul> Equipped with a 9-Spd 948TE Auto Transmission (Sales Code DFH). | | | MARKET APPLICABILITY:<br><div><input type="checkbox"/> NA<input type="checkbox"/> MEA</div> <div><input type="checkbox"/> SA<input checked="" type="checkbox"/> IAP</div> <div><input type="checkbox"/> EE<input type="checkbox"/> CH</div> | |

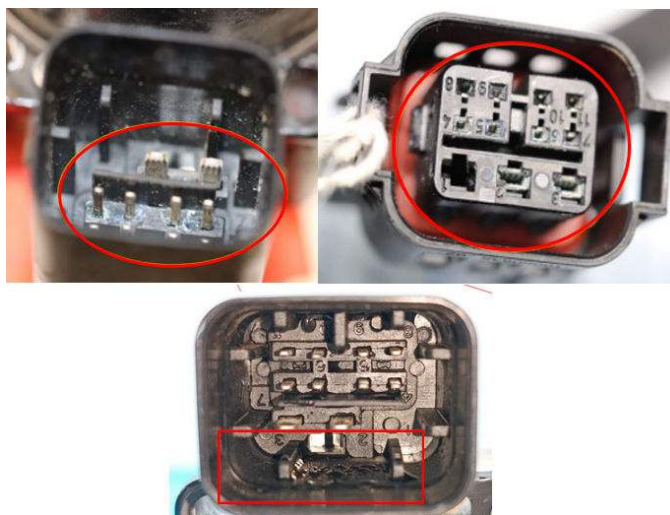
**Fig. 1**

5. Inspect for evidence of moisture on the connector pins at both the PTU and the shift actuator wire harness connectors [Fig. 1](#).

Wire Harness Connectors

6. Is moisture present on the connector pins?
- YES>>> Proceed to [Step 7](#).
  - NO>>> Proceed to [Step 11](#).
7. Replace the wire harness.
8. Clear any DTCs that may have been set.
9. Road test the vehicle for 8-10 km (5-6 miles).
10. Is DTC C2270-077, C2290-92, C2280-92, C2240-92, C2120-13, C2120-14 or C2120-15 present?
- YES>>> Proceed to [Step 11](#).
  - NO>>> This bulletin has been completed.
11. Remove the shift actuator from the PTU. Refer to the detailed service procedures listed in DealerCONNECT> Service Library under: 21 - Transmission and Transfer Case / Power Transfer Unit / Actuator, Shift / Removal.

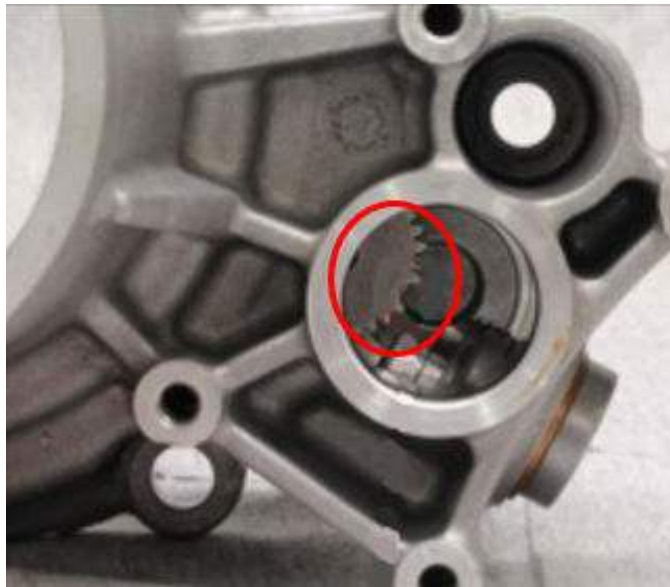
**Fig. 2**  
Intermediate Gear

12. Inspect if the intermediate gear has any broken teeth [Fig. 2](#).

13. Does the intermediate gear have any broken teeth?
- YES>>> Proceed to [Step 14](#).
  - NO>>> Proceed to [Step 15](#).
14. Replace the PTU along with the mating wire harness. Refer to the detailed service procedures listed in DealerCONNECT> Service Library under: 21 - Transmission and Transfer Case / Power Transfer Unit / Removal and Installation. Proceed to [Step 16](#).
15. Replace the shift actuator along with the mating wire harness. Refer to the detailed service procedures listed in DealerCONNECT> Service Library under: 21 - Transmission and Transfer Case / Power Transfer Unit / Actuator, Shift / Removal and Installation.
16. Clear any DTCs that may have been set.
