| <br><b>HYUNDAI</b><br><b>Technical Service Bulletin</b> | GROUP | NUMBER |
| | <b>BODY ELECTRICAL</b> | <b>24-BE-019H</b> |
| | <b>DECEMBER 2024</b> | <b>TUCSON (NX4A)</b> |
| <b>SUBJECT:</b> ACTIVE AIR FLAP ON-BOARD DIAGNOSTIC SENSORS REPLACEMENT | | |

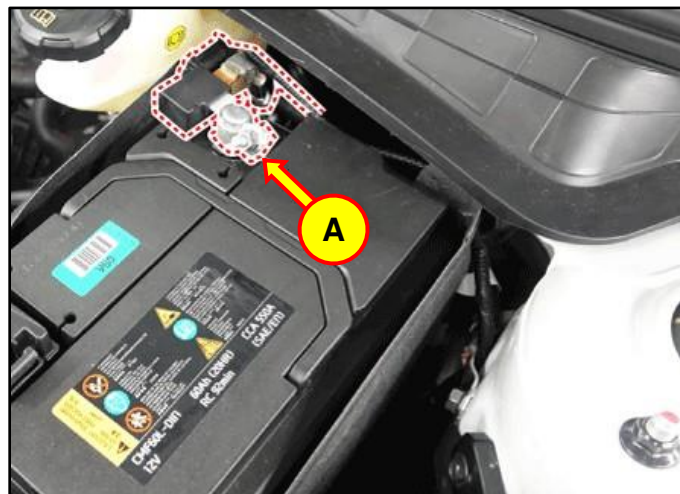
1. Turn **OFF** the ignition and disconnect the negative (-) battery terminal (A).

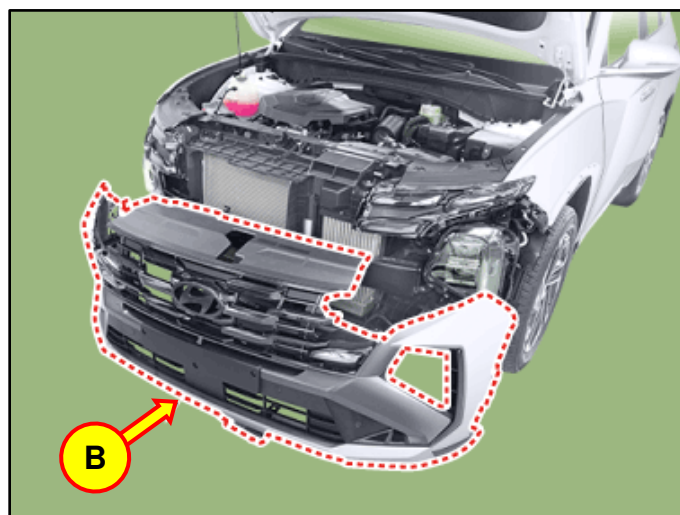
2. Remove the front bumper assembly (B) by referring to the shop manual:
  - 2025 > G 2.5 GDI THETA III > Body (Interior / Exterior / Electrical) > Front & Rear Bumper > Front Bumper Assembly > Removal and Installation

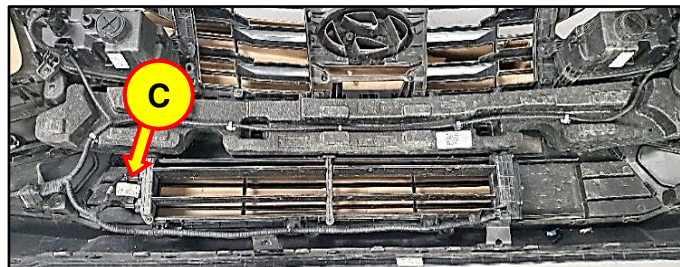
3. Locate 2 AAF sensors (C) on the front bumper.

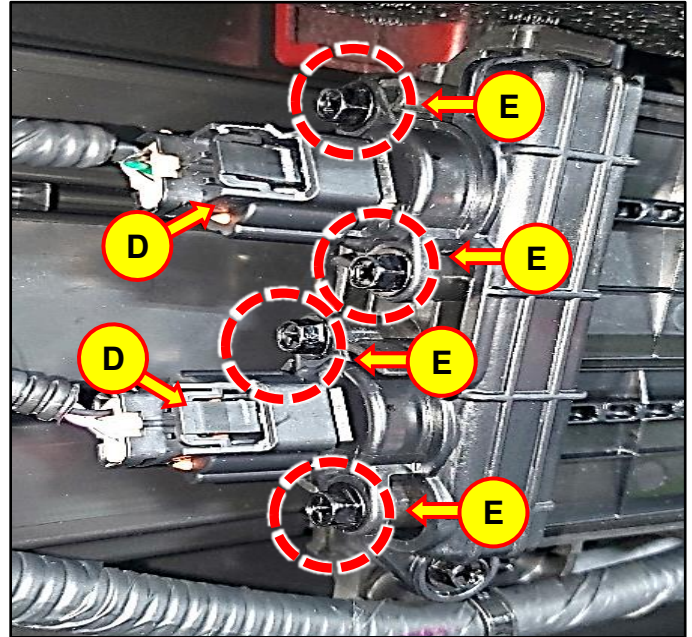
4. Disconnect both AAF sensor connectors (D) and remove the mounting screws (E). Remove the AAF sensors.

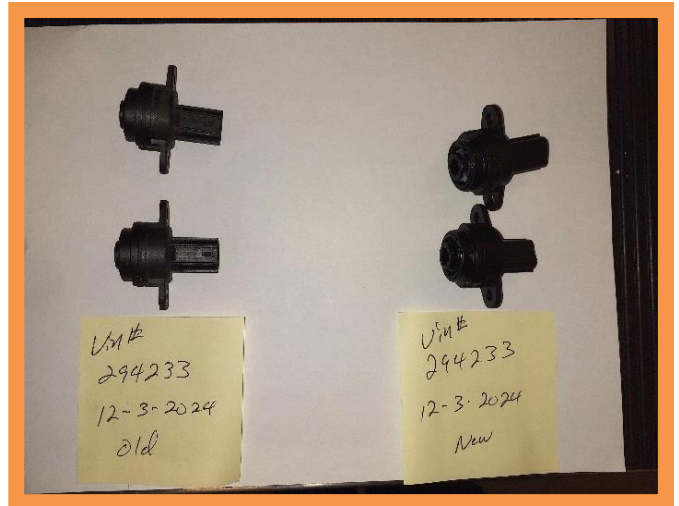
Using STUI, take a photo of the new and old sensors with the last 6 digits of the VIN and the date of repair on a piece of paper.
