| <br><b>Technical Service Bulletin</b> | <b>GROUP</b><br><b>BODY ELECTRICAL</b> | <b>NUMBER</b><br><b>24-BE-020G</b> |
| | <b>DATE</b><br><b>DECEMBER 2024</b> | <b>MODEL(S)</b><br><b>GV70 (JK1A)</b> |
| <b>SUBJECT:</b> ACTIVE AIR FLAP ON-BOARD DIAGNOSTIC SENSORS REPLACEMENT | | |

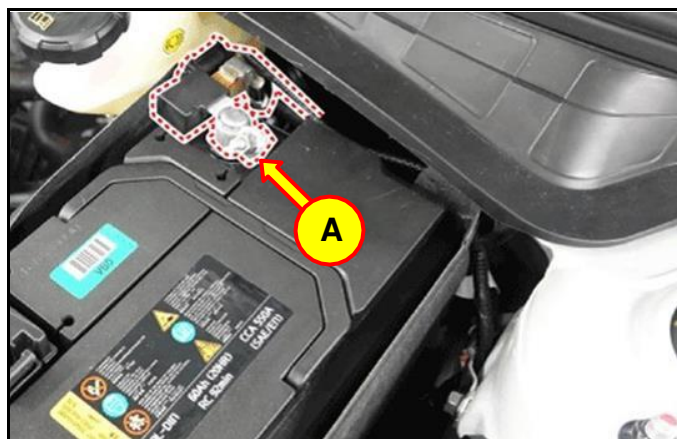
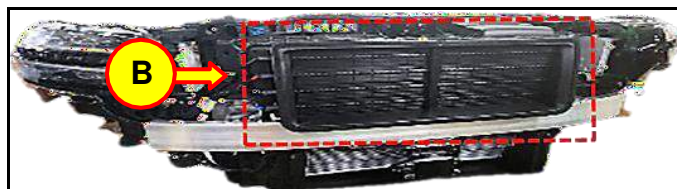
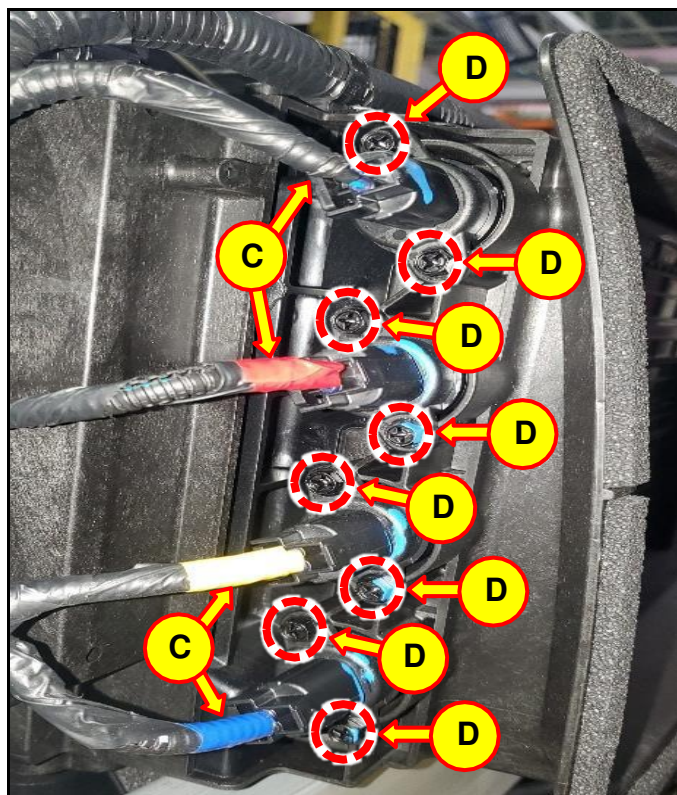
**Description:** Certain 2025MY GV70 (JK1A) vehicles may experience an illuminated check engine light for DTC P059A from a faulty connection due to improper soldering within the sensor components. This bulletin outlines the procedure to replace the active air flap (AAF) on-board diagnostic (OBD) sensors to resolve this issue.

1. Turn **OFF** the ignition.
2. Disconnect the negative (–) battery terminal (A) by referring to the shop manual:
  - **G 2.5 T-GDI THETA III >Body (Interior/Exterior) > Front Bumper > Front Bumper Assembly > Replacement**
3. Locate **4** AFF OBD sensors (B) on the FEM module.
4. Remove the wire connections (C) and 2 screws (D) from each AAF OBD sensor, shown in the red circles.
