# REMOTE DIAGNOSTICS REPAIR INSTRUCTIONS

DTC: P2560-00

Bulletin: RD24-039 Date: December 17, 2024

**Description:** Engine Coolant Level Low – Elevated Coolant & Oil Temperature

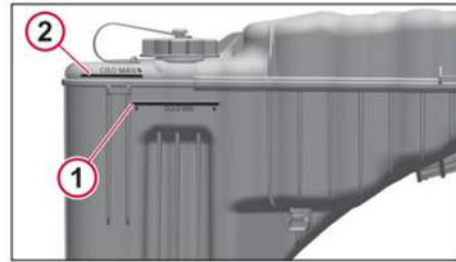
| <p>Check engine coolant level.<br/>Make sure that the coolant level is within the markings on the expansion tank. 1 Cold Minimum Line 2 Cold Maximum Line.<br/>If coolant level is low, then visually check for leaks.<br/>Proceed with repairs as necessary.</p> | |

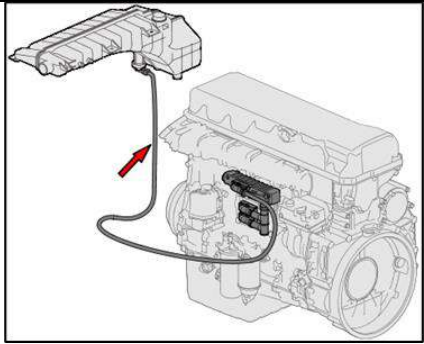
| <p>Visually check that wiring harness is not damaged.<br/>Connector check</p> <ul style="list-style-type: none"><li>• Check that the connectors are properly connected and locked into position</li><li>• Disconnect and check the component connector</li><li>• Inspect pins and terminals for oxidation or corrosion</li><li>• Ensure that the pins and terminals are locked into the connectors and that they are not pushed back out of the sockets</li><li>• Check that the pins and terminal are not damaged (which can cause poor connection)</li></ul> | |
