# TECHNICAL SERVICE BULLETIN

## Equipped With Minor Feature Code HUKAJ - 400 Watt DC/AC Inverter System Inoperative With B1330:9A In The BCM

24-2443

20 December  
2024

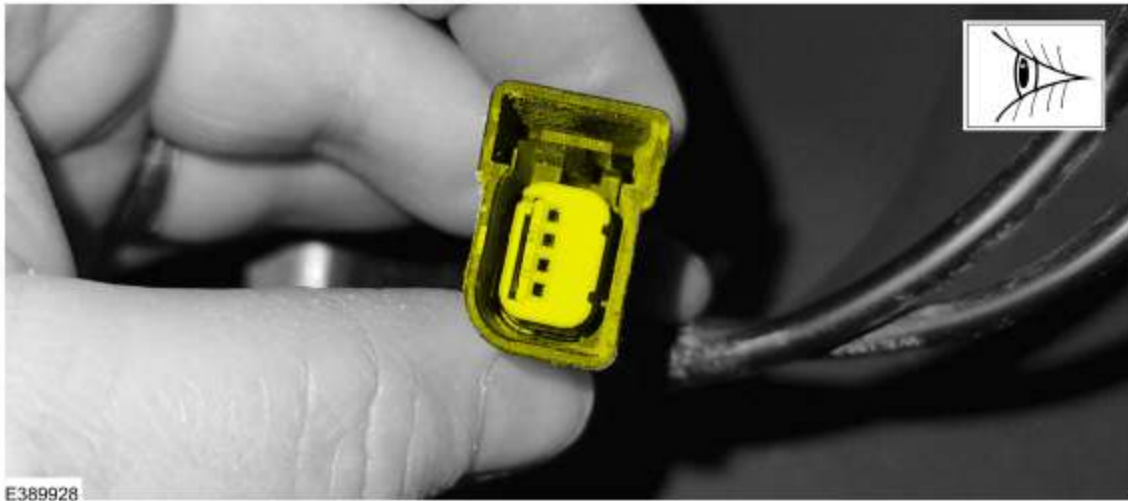
Figure 2

2. Using a suitable tool, carefully cut and remove the pickup bed AC power outlet socket harness retainer from the pickup bed AC power outlet socket harness. Discard the retainer.
3. Is the vehicle a Raptor?
  - (1). Yes - proceed to Step 4.
  - (2). No - proceed to Step 7.
4. For Raptor vehicles, inspect connector C4628 for the presence of corrosion, dirt and/or damage. Is corrosion, dirt and/or damage present in connector C4628? (Figure 2)

7. Inspect connector C4628 for the presence of corrosion, dirt and/or damage. Is corrosion, dirt and/or damage present in connector C4628? (Figure 2)

**5.** Replace the pickup bed AC power outlet socket assembly. Refer to WSM, Section 414-05. Proceed to Step 6.

**6.** Replace the body side harness assembly (13A409) of connector C4628. To gain access to the body side harness assembly (13A409), remove the left pickup bed lower moulding. Refer to WSM, Section 501-08 Exterior Trim and Ornamentation > Removal and Installation > Rear Quarter Panel Moulding. Then remove the three rearmost screws and the four rearmost retainers from the left rear fender moulding. (Figures 3-4) This will allow sufficient access to the remainder of the body side harness assembly (13A409). (Figure 5) Proceed to Step 8.

(1). Yes - replace the pickup bed AC power outlet socket assembly. Refer to WSM, Section 414-05. Replace the body side harness assembly (13A409) of connector C4628. Proceed to Step 8.

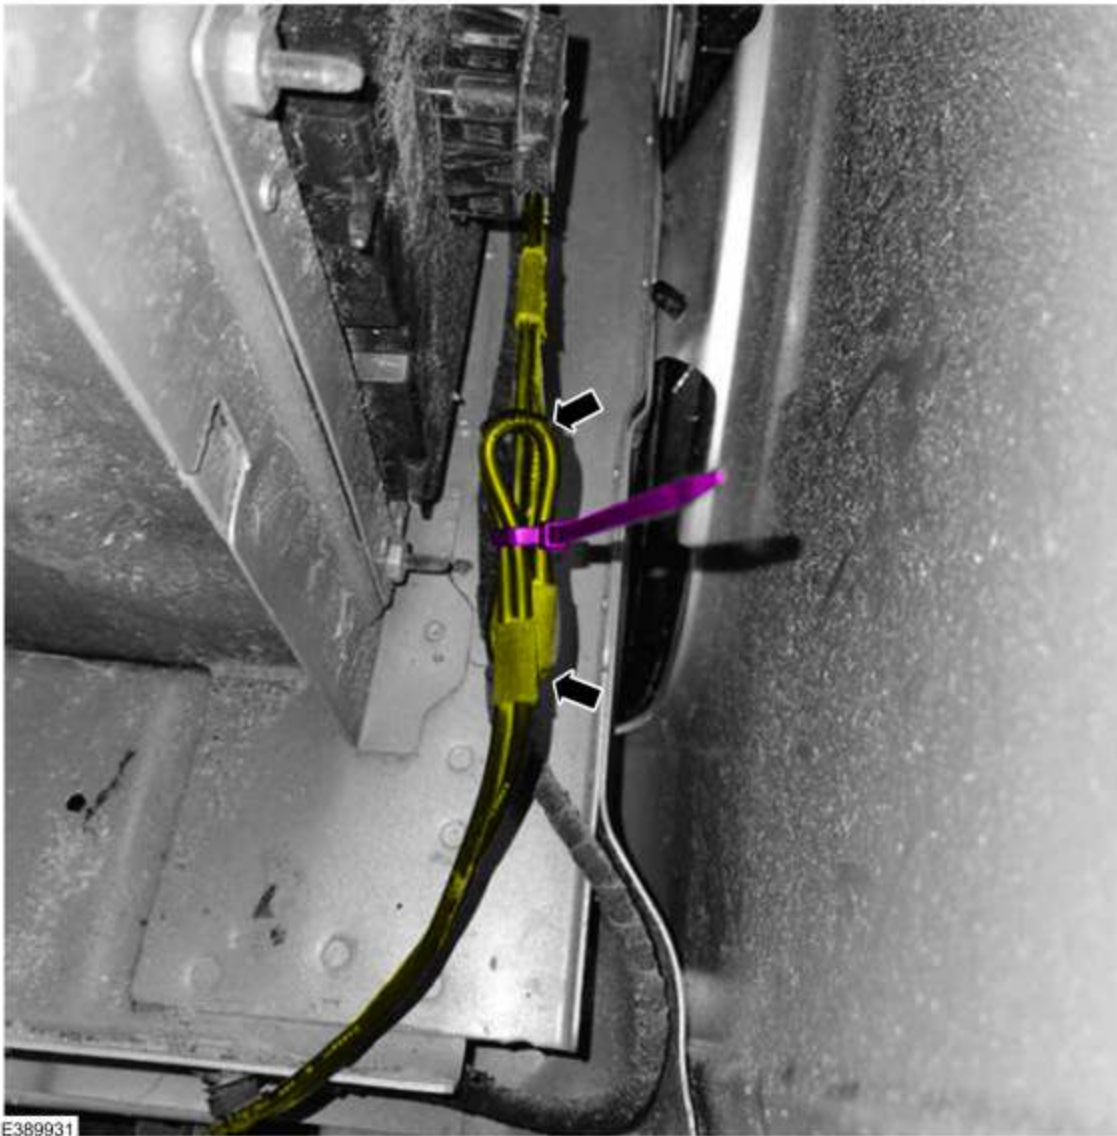
Figure 8

**CAUTION:** The bend radius of the pickup bed AC power outlet socket harness should be no less than 4 mm. Hard kinks and tight bends of the pickup bed AC power outlet socket harness can lead to wire damage.

**10.** Fold approximately 7 in. (185 mm) of the remaining/loose pickup bed AC power outlet socket harness in 2 bends just behind the pickup bed AC power outlet socket panel. Secure the folded wire with a wire tie. Inspect the routing of the harness to make sure it is not pulled too tight against the body sheet metal near the harness retainer and provides just enough length. (Figure 8)
