# Technical Service Bulletin

## 93 PSS Q8 e-tron: Charging flap module without search illumination; P33E300; B1A8AF3

93 24 44 2073481/5 December 16, 2024. Supersedes Technical Service Bulletin Group 93 number 24-27 dated November 4, 2024 for reasons listed below.

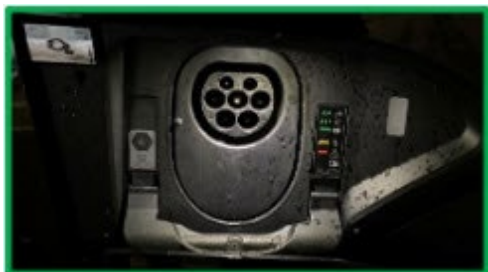
**Figure 1:** Vehicle with functioning orientation light in the charging flap module.

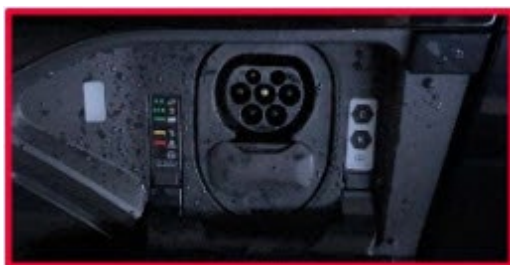
If the vehicle is only equipped with single charging flap module the orientation light does not work. An error in the OBC (00C6) software means that the orientation light LED is not activated when the vehicle is equipped with only one charging flap module.

**Figure 2:** Vehicle with a non-functioning orientation light in the charging flap module.

1. Explain to the customer that a solution is expected to be available by the end of the 1st quarter of 2025 (subject to change) and that no repairs are necessary at this point.
2. Do not replace any components for this condition since this will not resolve the customer's concern.
3. Create a PSS record in the PSS application through the Pending Service Solutions (PSS) link in AccessAudi (under *Related Links* >> *Service*).
