# Technical Service Bulletin

## 93 e-tron GE electric drive motor leak P0AA600

93 24 46 2073858/5 December 19, 2024. Supersedes Technical Service Bulletin Group 93 number 24-29 dated November 7, 2024 for reasons listed below.

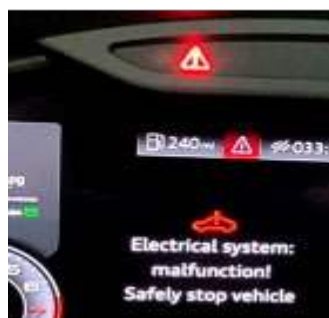
- A Drive System/Electrical System Malfunction message (Figure 1) appears in the in the instrument cluster; the warning may not be present at the time of inspection.

**Figure 1.** Warning lamp associated with message.
