| | ELE | 2024-2025MY<br>EV9 (MV1) |
| | 362 | January 2025 |
| TECHNICAL SERVICE BULLETIN | | |
| SUBJECT: SERVICE ACTION: SHIFT CONTROL UNIT<br>LOGIC IMPROVEMENT (SA594) | | |

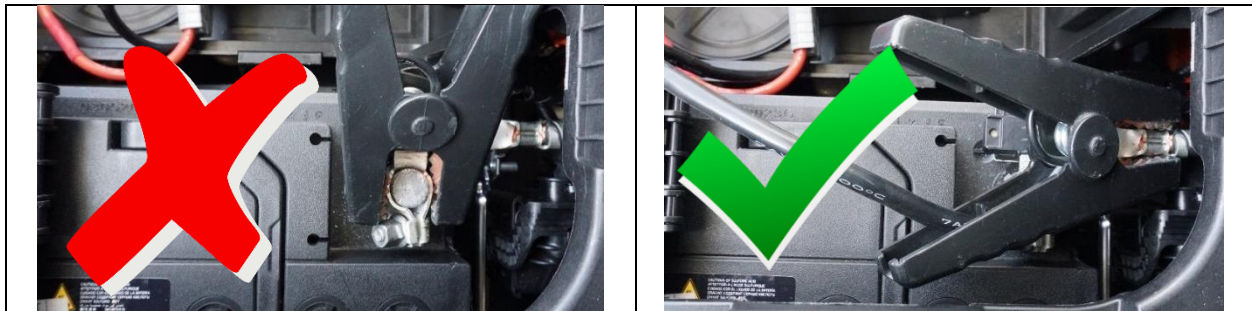
[Connect the negative \(-\) terminal to the battery as shown below.](#)
