# TECHNICAL SERVICE BULLETIN

EC24-012A

ITB24-017A

## ENGINE ROOM SUB-HARNESS

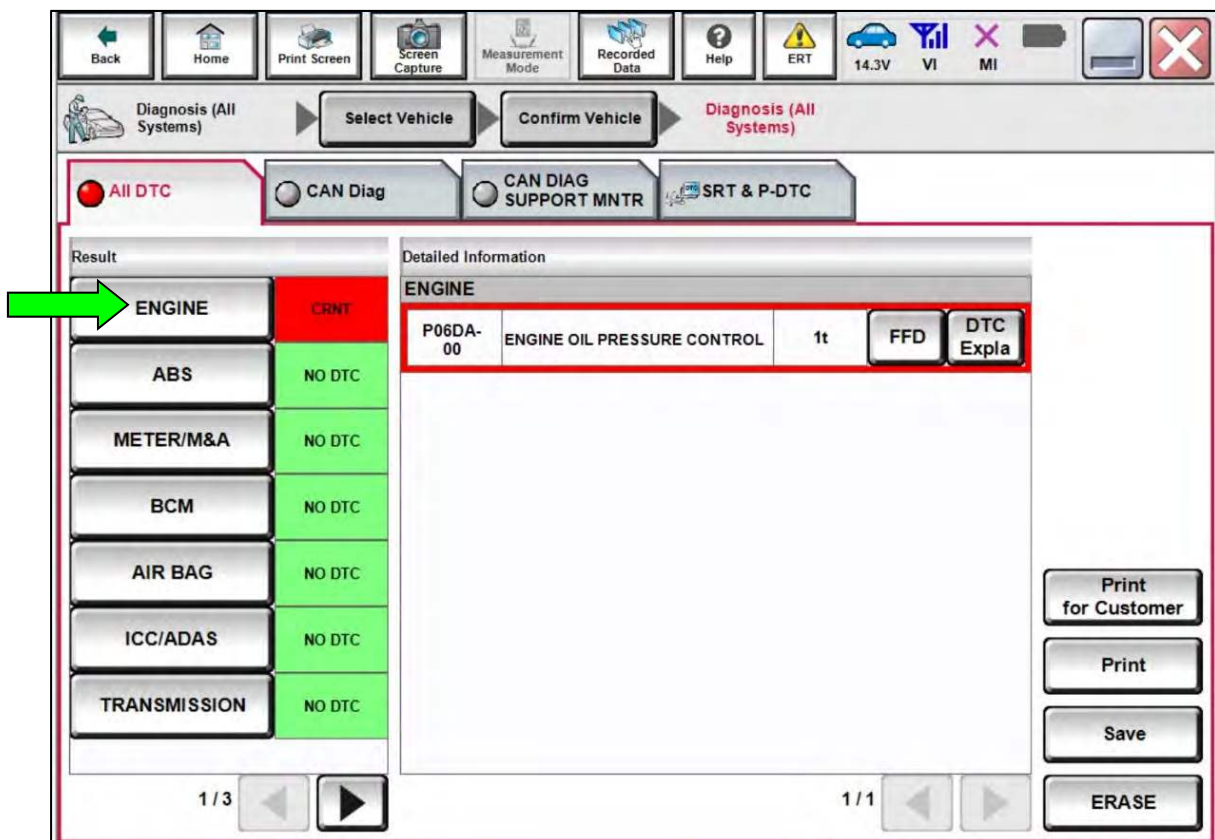
Figure 7

15. Check to see if DTC P06DA-00 for “ENGINE-OIL PRESSURE CONTROL” is “CRNT” in **ENGINE**.
  - If DTC P06DA-00 is current in the ENGINE:
    - a. Print the DTC and description and attach it to the repair order.
    - b. Replace the engine room sub-harness located in the engine oil pan.
      - On 2WD models, continue to step 16 on page 7.
      - On AWD models, skip to step 25 on page 10.
  - If DTC P06DA-00 is NOT current in the ENGINE, this bulletin does not apply. Refer to the ESM for further diagnostic information.
  - If additional DTCs, other than P06DA-00, are present in the ENGINE, refer to the ESM for further diagnostic information and repair first, then return to step 15.

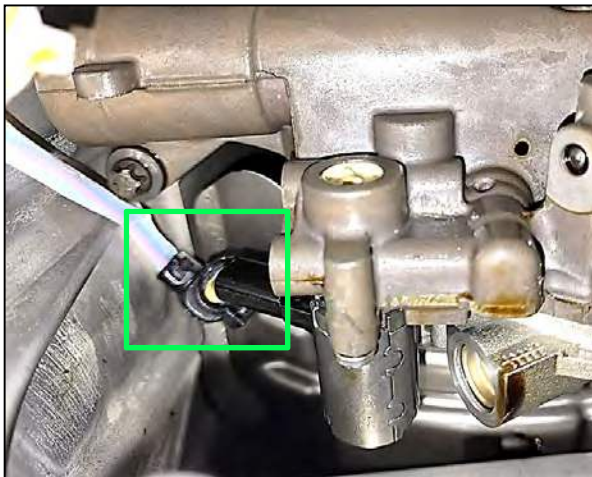
Figure 22

To avoid damage to the oil pump solenoid valve, closely follow step 31 to prevent the oil pump valve wiring harness connector from contacting the oil pan.

- a. Position the oil pump valve wiring harness connector of the NEW engine room sub-harness connector at an angle as shown in Figure 22.
- b. Connect and lock the wiring harness connector.
