# TECHNICAL SERVICE BULLETIN

| DA21-003B | NTB21-040B | January 21, 2025 |

## DTCS B2740-87, B2744-87, AND/OR B274D-87 STORED

**APPLIED VEHICLES:** 2021 Rogue (T33)

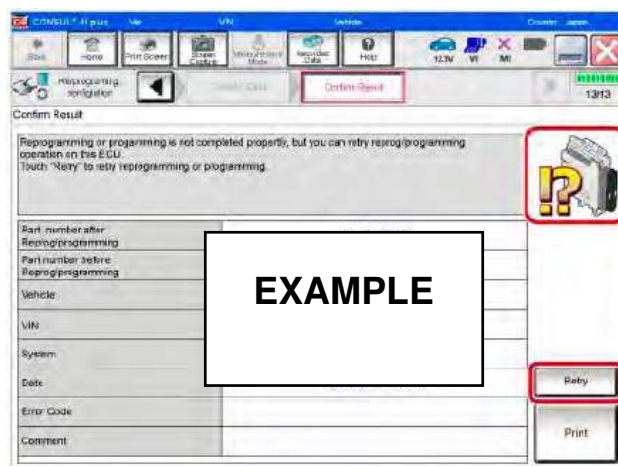
Figure 23

**If reprogramming does not complete and the “!?” icon displays as shown in Figure 23:**

- Check battery voltage (12.0 - 13.5 V).
- Ignition is ON, engine OFF.
- External Bluetooth® devices are OFF.
- **All** electrical loads are OFF.
- **Select retry and follow the on screen instructions.**
- “Retry” may not go through on first attempt and can be selected more than once.

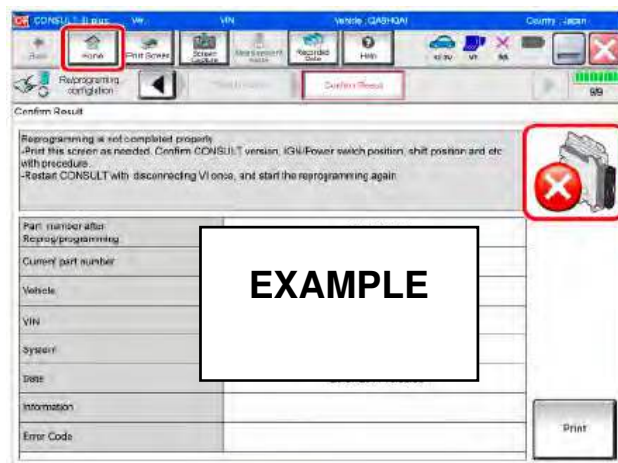
Figure 24

**If reprogramming does not complete and the “X” icon displays as shown in Figure 24:**

- Check battery voltage (12.0 – 13.5 V).
- CONSULT A/C adapter is plugged in.
- Ignition is ON, engine OFF.
- Transmission is in Park.
- All C-III plus / VI cables are securely connected.
- All C-III plus updates are installed.
- **Select Home, and restart the reprogram procedure from the beginning.**
