# Service Bulletin

Bulletin No.: PI1257

**Subject:** Revised Upper Intake Manifold with Relocated MAP Sensor for DTC P0106

**Models:** 2007–2009 Chevrolet Silverado  
2007–2009 GMC Sierra  
Equipped with 6.6L Duramax Diesel Engine (RPO LMM)

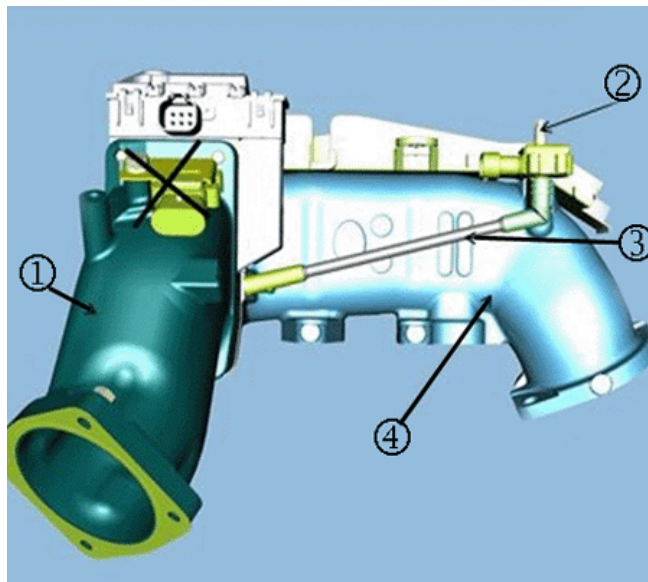
3714283

During 2009 production the MAP sensor was relocated from the intake pipe to the upper intake manifold to prevent ice from building up in the MAP sensor and setting DTC's. The MAP sensor on this new design was located on the top of the upper intake manifold and connected through a hose which connects to a pressed in hose barb. The old design upper intake manifold without the hose barb is no longer available.

If an upper intake manifold is ordered, it will be of the new design. This hose barb can be plugged with a second MAP sensor and the MAP sensor tube if there have been no icing issues, or the harness can be extended from the old sensor to the new sensor location to reduce chances of icing.
