**HYUNDAI**  
**Technical Service Bulletin**

**25-01-023H**

**SUBJECT:** EGR VALVE ASSEMBLY AND GASKET REPLACEMENT  
(SERVICE CAMPAIGN 9B3)

**Description:** The exhaust gas recirculation (EGR) valve assembly in certain vehicles (listed below) may contain a sensor that was contaminated with solder flux during manufacturing, which could potentially result in an electrical short. An electrical short within the EGR valve could lead to a Malfunction Indicator lamp (MIL) illumination (P0405, P0642, P0652, P0404/P049D/P240F). Follow the information in this bulletin to replace the EGR valve assembly and gasket.

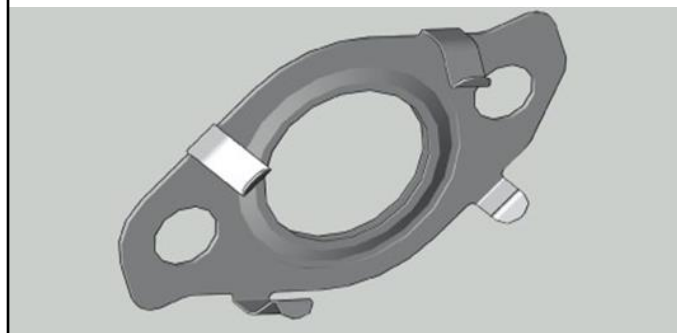
Gasket

Orient the EGR pipe gasket as shown in photo.

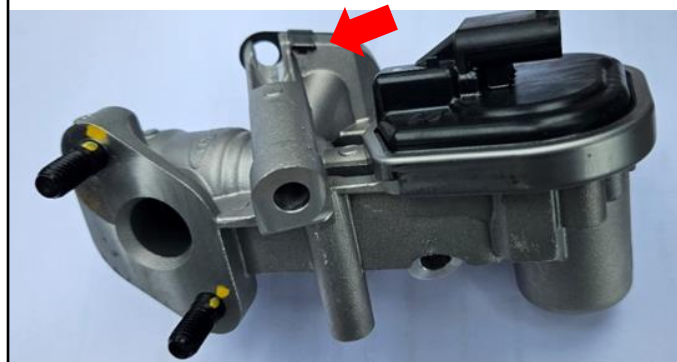
EGR Valve Assembly

Mount the EGR pipe gasket before installing the EGR valve assembly.

Tighten the EGR control valve to the specified torque.

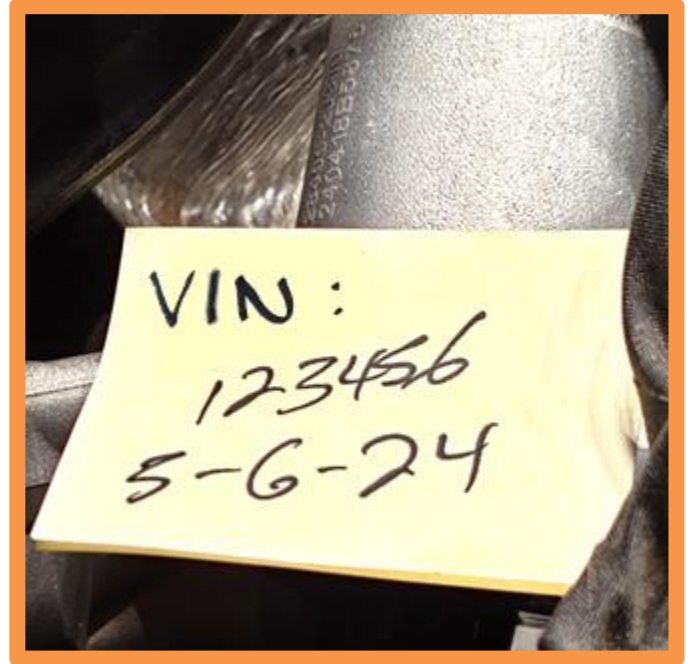
**Using STUI, take a photo of the newly installed EGR Valve capturing the production stamp with the last 6 digits of the VIN and the date of repair on a piece of paper.**

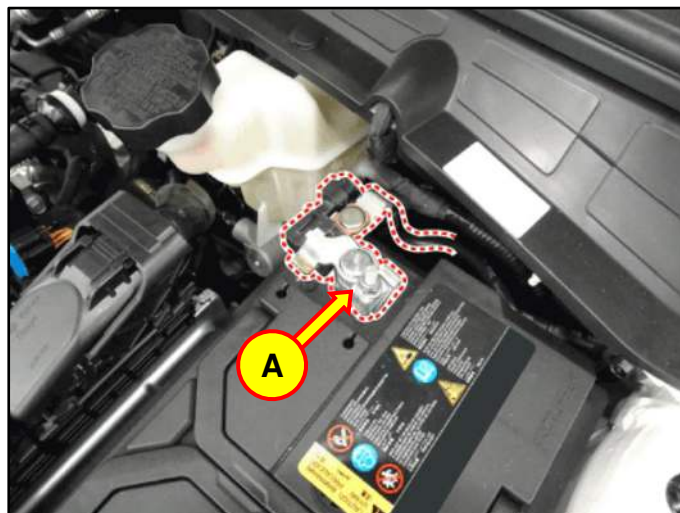
Disconnect the negative (–) battery terminal (A).

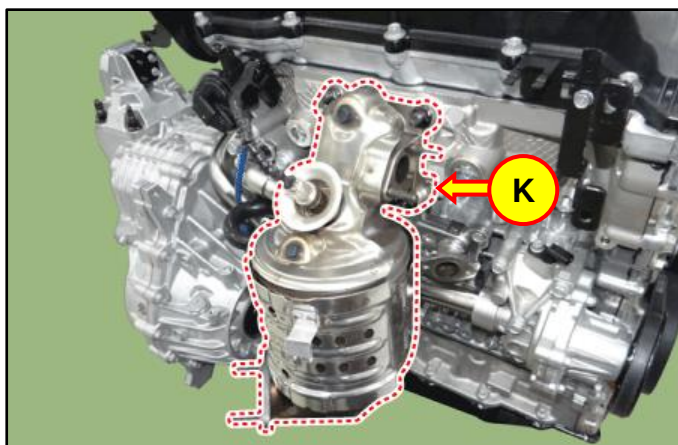
8. Refer to the shop manual to remove the water inlet pipe (J) and exhaust manifold (K):
- **Engine Mechanical System > Cooling System > Integrated Thermal Management Module (ITM) > Repair procedures**
  - **Engine Mechanical System > Intake And Exhaust System > Muffler > Repair procedures**

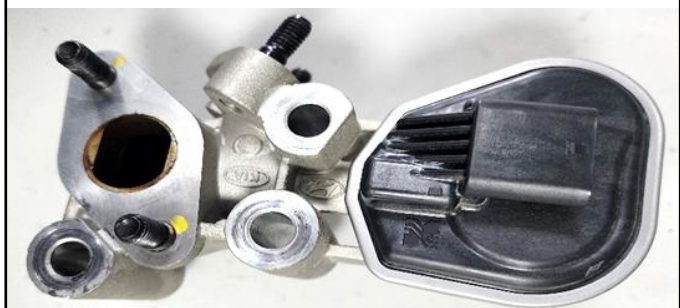
EGR Valve Assembly

13. Install the supplied EGR control valve and gasket.

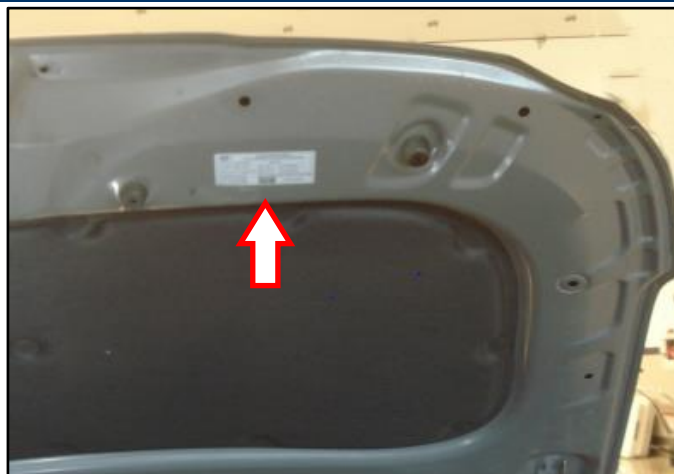
1. Fill in the Dealer Code and Date on the Campaign Sticker, and apply adjacent to the existing Emission Label, on the underside of the hood, as shown.
